Belzona Extends the Life of Mixing Blades

Application: SHM-Solids Handling Machinery

Customer Location: Plaster Production Factory, Slovakia

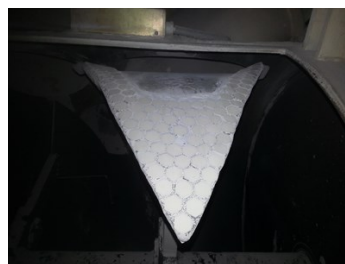
- * 1. Mixing machine ,
- * 2. Belzona 1812 and 9811 application ,
- * 3. Anchor after 12 months mixing ,
- * 4. Anchors after 4 years in service ,

Conventional welding of hard steel wear plates was very complicated. After a 6 month trial with Belzona protection there was no damage, after this the customer ordered all future anchors to use the Belzona protection system.
