Chemical canalization entry repaired with Belzona

Industry: Chemical & Petrochemical
Application: TCC-Tanks and Chemical Containment Areas
Substrate: Concrete / Steel
Products: * Belzona 4131 (Magma-Screed) ,
* Belzona 5811 (Immersion Grade) ,

Customer Location: Petrochemical company, Slovakia
Application Date: 2016

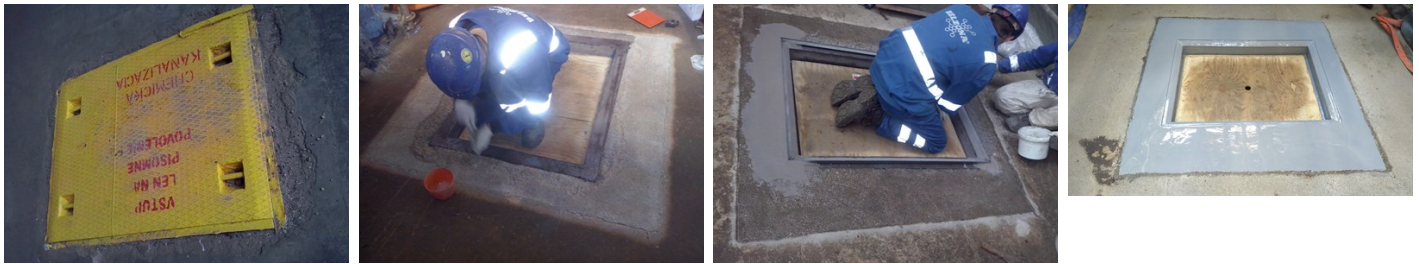
Photograph Descriptions

Corrosion of the steel frame and damage to the concrete

- * 1. Chemical canalization entry. ,
- * 2. Belzona Conditioner application ,
- * 3. Belzona 4131 application ,
- * 4. Belzona 5811 in 2 layers ,

The concrete was destroyed from chemicals.

Application was carried out in accordance with Belzona Know-How System Leaflet TCC 9
