# Large storage tank protected with Belzona

Industry: *Chemical & Petrochemical*  
Application: *TCC-Tanks and Chemical Containment Areas*  
Substrate: *Steel*  
Products: *\* Belzona 5811 (Immersion Grade) ,  
\* Belzona 1111 (Super Metal) ,*

Customer Location: *Petrochemical company, Slovakia*  
Application Date: *2015*

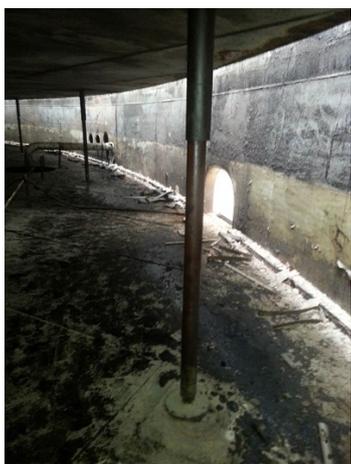
*The tank had been in service for twenty years and was suffering extensive corrosion damage*

- \* 1. Tank after 20 years. ,
- \* 2. Blasting of the basin ,
- \* 3. Visible damages after blasting ,
- \* 4. Belzona 5811 coating applied in 2 layers ,

Customer needed quick and quality repair. All protection was realized with Belzona 5811. Deep corrosion was rebuilt with Belzona 1111.
