# BELZONA BECOMES STANDARD REPAIR ON BOTTLE FILLING EQUIPMENT

**Industry:** General Industry  
**Application:** ENC-Engines and Casings  
**Substrate:** Cast iron  
**Products:** \* Belzona® 4301 (Magma CR1 Hi-Build) ,  
\* Belzona® 4311 (Magma CR1) ,

**Customer Location:** Soft Drink Bottler, Michigan  
**Application Date:** April 2006

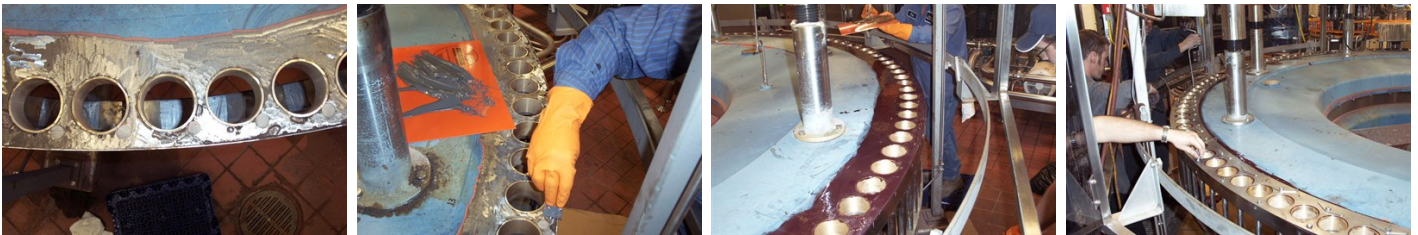
*Corrosion from spills causes the bottle location tooling to loosen. The loose tooling causes more spillage and an ever worsening corrosion.*

- \* Bushings installed and table prepared. Note deep corrosion pitting. ,
- \* Surface restoration with Belzona® 4301. ,
- \* Surface coated with Belzona® 4311. ,
- \* Stainless steel plates seated in Belzona for full support and corrosion protection. ,

Tooling pockets are rebored and bushings installed. Where the pockets are corroded excessively and bushings cant be shrunk fit they are installed in Belzona® 4301 as per Belzona Know-How System Leaflet ENC-3b. The surface is then repaired with Belzona® 4301 and coated with Belzona® 4311 as per System leaflets TCC-3 & TCC-5. Stainless plates are installed and seated in the wet Belzona® 4311 for permanent protection from future spillage.
