Wear Plates in Rolling Mill Secured with Belzona

ID: 7620

Customer Location: Steel plant, Slovakia
Application Date: 2015

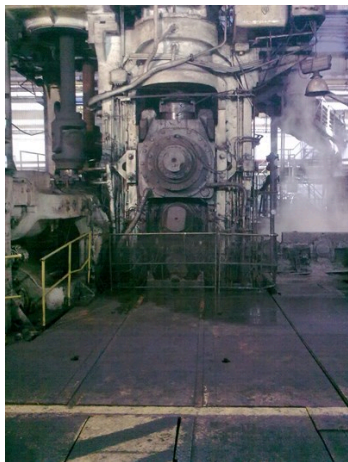
* 1. The Rolling Mill 2. Testing of the Belzona 1321 injection 3. Wear plate 4. Belzona 1321 injection in action ,

Wear plates have to be adjusted, tightened and then Belzona 1321 injected to create irregular shim between plate and mill frame. This is a routine application for Belzona 1321 which demonstrates excellent compressive strength required for this application.
