# OFFSHORE DECK REPAIRED AND COATED WITH BELZONA PROTECTIVE SYSTEMS

ID: 7622

Offshore Oil Platform Deck

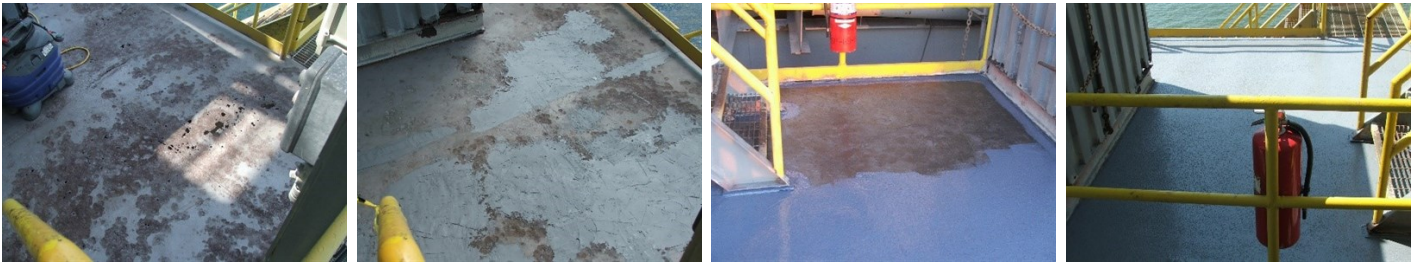
The surface of the deck had become weak due to severe corrosion and metal loss of the platform deck.

- \* Corrosion and through-wall holes in the deck ,
- \* Holes repaired with Belzona 1121 ,
- \* Application of Belzona 5821 incorporating Belzona 9211 ,
- \* Completed application of Belzona 5233, a UV stable top coat ,

The deck area was cleaned and properly prepared. The through-wall holes were repaired with Belzona 1121. Then, Belzona 5821 was applied to provide a wear resistant barrier and Belzona 9211 was incorporated into Belzona 5821 to provide a grip system. The application was finalized using Belzona 5233 to provide UV stability.

Belzona could be safely applied whilst the platform was in operation and eliminated the need for hot work. The deck was completely renovated.
