OFFSHORE DECK REPAIRED AND COATED WITH BELZONA PROTECTIVE SYSTEMS

ID: 7622

Offshore Oil Platform Deck

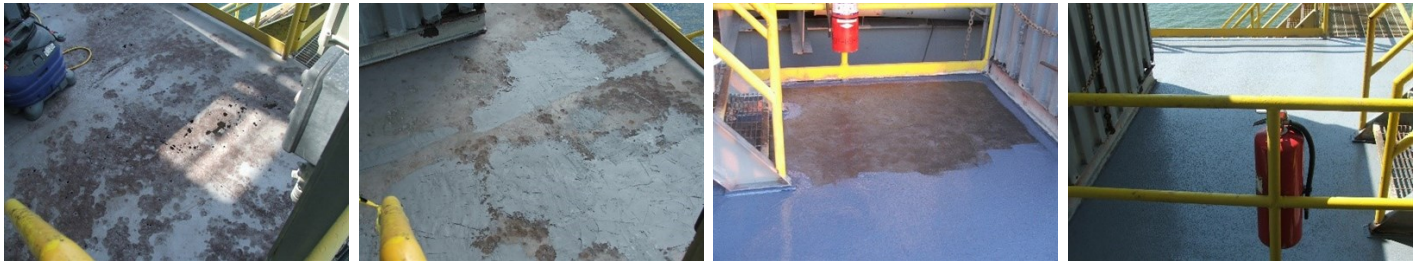
The surface of the deck had become weak due to severe corrosion and metal loss of the platform deck.

- * Corrosion and through-wall holes in the deck ,
- * Holes repaired with Belzona 1121 ,
- * Application of Belzona 5821 incorporating Belzona 9211 ,
- * Completed application of Belzona 5233, a UV stable top coat ,

The deck area was cleaned and properly prepared. The through-wall holes were repaired with Belzona 1121. Then, Belzona 5821 was applied to provide a wear resistant barrier and Belzona 9211 was incorporated into Belzona 5821 to provide a grip system. The application was finalized using Belzona 5233 to provide UV stability.

Belzona could be safely applied whilst the platform was in operation and eliminated the need for hot work. The deck was completely renovated.
