OFFSHORE DECK REPAIRED AND COATED WITH BELZONA PROTECTIVE SYSTEMS

Application: FPA-Floor Problem Areas

Offshore Oil Platform Deck

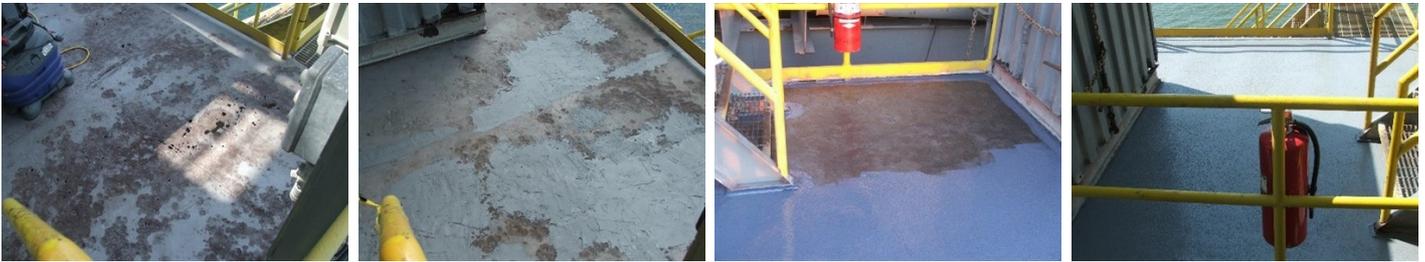
Photograph Descriptions

The surface of the deck had become weak due to severe corrosion and metal loss of the platform deck.

- * Corrosion and through-wall holes in the deck ,
- * Holes repaired with Belzona 1121 ,
- * Application of Belzona 5821 incorporating Belzona 9211 ,
- * Completed application of Belzona 5233, a UV stable top coat ,

The deck area was cleaned and properly prepared. The through-wall holes were repaired with Belzona 1121. Then, Belzona 5821 was applied to provide a wear resistant barrier and Belzona 9211 was incorporated into Belzona 5821 to provide a grip system. The application was finalized using Belzona 5233 to provide UV stability.

Belzona could be safely applied whilst the platform was in operation and eliminated the need for hot work. The deck was completely renovated.
