BELZONA REPAIRS VERTICAL SHAFT IN-SITU

ID: 7623

Industry: Food & Drink
Application: FBC-Fans, Blowers and Compressors

Substrate: Hardened Carbon Steel Shaft
Products: * Belzona 1511 (Super HT-Metal),

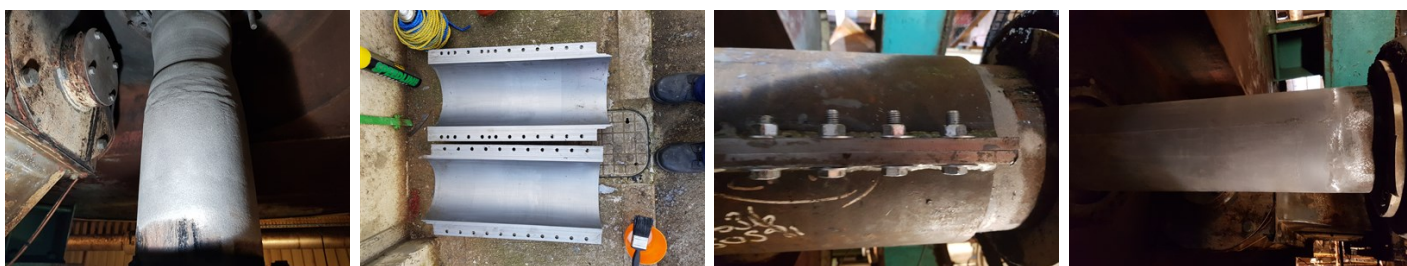
Photograph Descriptions

The damage caused to the shaft was causing product to fall onto the workshop floor causing a safety risk, but more importantly causing a loss in revenue due to product dropping through the eroded shaft packing area onto the floor. The client required a solution to repair in-situ without the need to remove the equipment and dismantle the shaft, and machine in a workshop.

- * 1. Shows Severely damaged vertical shaft ,
- * 2. Pre-Machined formers ,
- * 3. The product applied to the shaft with the former ,
- * 4. Completed Application ,

A D.T. Machine has a shaft that stands vertically between two floors, the vertical shaft which runs between the electric motor and the rotating element had deteriorated badly, due to erosion, causing a loss of product coming through the stuffing box area.

The application was carried out in accordance with a modified version of Belzona Know How System leaflet FBC-13, a former had been pre-machined, coated with release agent. The surface of the shaft was prepared using grit blasting. Belzona 1511 was applied to the former and shaft, the shaft was aligned in position and tightened and left to cure. The next day the former was removed and the edges machined back, once this was completed, a force cure was used to further increase the temperature resistance of the Belzona 1511.

The in-situ application saved the customer over £20,000 in shut down costs and the complications involved with replacing the shaft. Belzona 1511 has good resistance to the operating conditions and will prolong the life of this shaft.
