Brisbane City Center Steps Made Safe by Belzona

Industry: Buildings & Structures
Application: FPA-Floor Problem Areas
Substrate: Concrete
Products: * Belzona 4111 (Magma-Quartz) ,

Customer Location: Brisbane City Centre, Australia
Application Date: 2017

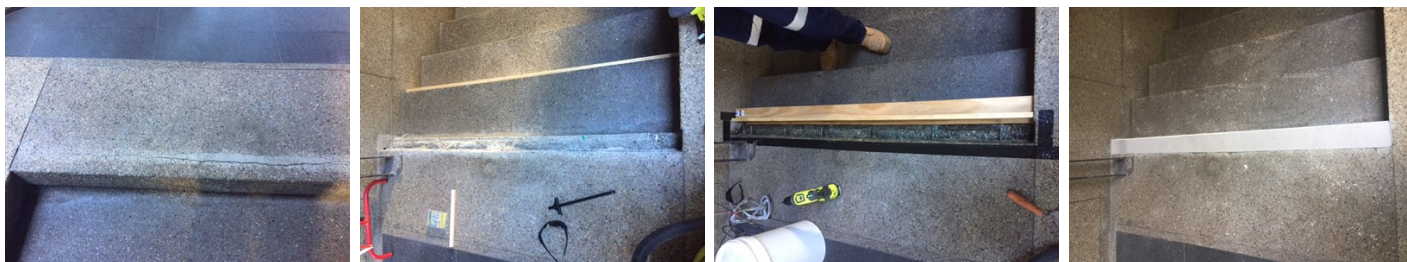
Photograph Descriptions

This damaged step was proving rather dangerous as there was a large volume of pedestrian traffic in the area.

- * 1. Broken step ,
- * 2. Loose concrete removed ,
- * 3. Former installed ,
- * 4. Completed repair back in service ,

An overhanging step in the centre of Brisbane had become worn and caused broken and loose concrete to cause a trip hazard.

The application was carried out in accordance with Belzona System Leaflet FPA-5. Initially, the broken step was demolished, before rebar was drilled and inserted to provide additional strength. The area was correctly prepared and Belzona 4111 was applied into the specially-constructed form-work.

The client was familiar with Belzona from other similar repairs and understood the benefits of the concrete repair materials over their traditional counterparts. In fact, the repair only took one day to complete, with the former removed the following day, allowing the step to be available to pedestrians very quickly.
