Belzona SuperWrap Repairs Offshore Pipes

Industry: Oil & Gas
Application: VPF-Valves, Pipes and Fittings
Substrate: Carbon steel
Products: * Belzona SuperWrap II System ,

Customer Location: Texas, USA
Application Date: April 2017

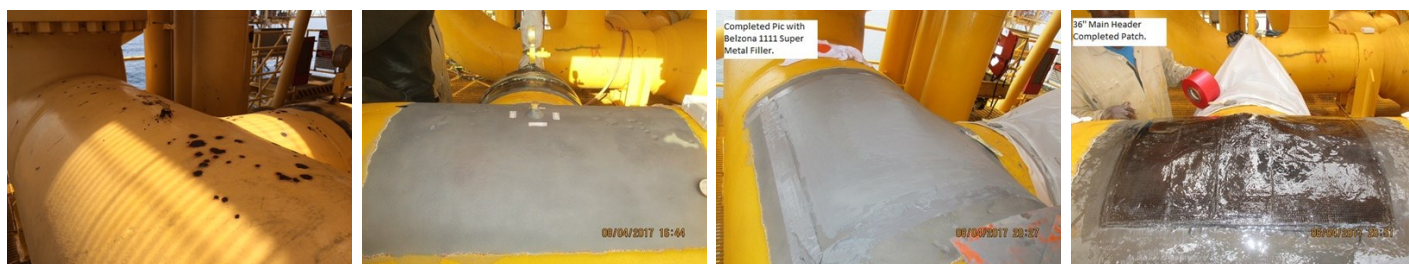
Photograph Descriptions

External Corrosion caused damage to the pipe, they also wanted to seal the thread-o-lets, which were no longer required. The repair had to be compliant to ASME PCC-2 and no hot work was permitted.

- * 1. Repair location. ,
- * 2. Grit blasted surface. ,
- * 3. Pit filling carried out with Belzona 1111. ,
- * 4. Finished SuperWrap II repair. ,

Application carried out in accordance with a modified version of Belzona System Leaflet VPF-11.

The majority of the large diameter pipe was in a good condition so a patch was just more practical and economical than a replacement.
