BELZONA PROTECTS AUGER MIXER

Application: SHM-Solids Handling Machinery

Customer Location: Mineral producer, Massa, Italy

Screw auger used in production of Calcium Carbonate

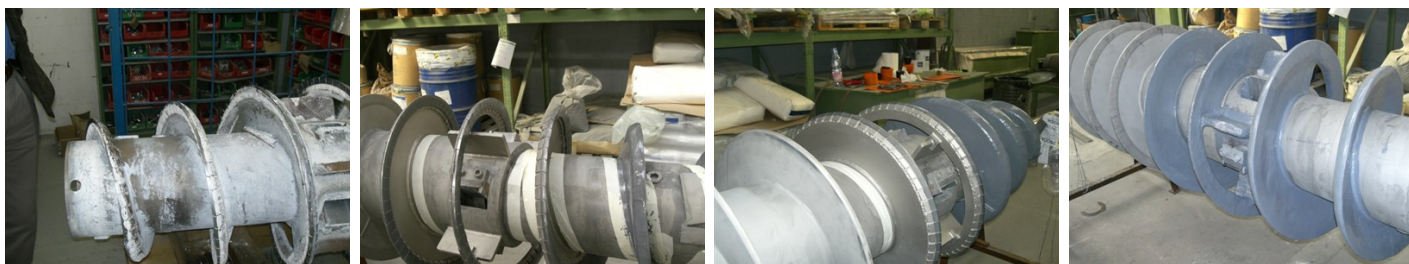
Photograph Descriptions

Severe abrasion wears shaft and flights. Hard inserts welded on edges.

* Auger before refurbishment , * Grit blasted and application underway , * Partially coated with Belzona® 1321 , * Application almost complete ,

Application carried out in accordance with Belzona Know-How System Leaflet SHM-14

The Belzona system is renewed after 2 years but protects structure of the auger from the severe abrasion present.
