# BELZONA HANDLES STRESS CRACK CORROSION AT A JUICING PLANT

ID: 7641

Substrate: Stainless steel pipe

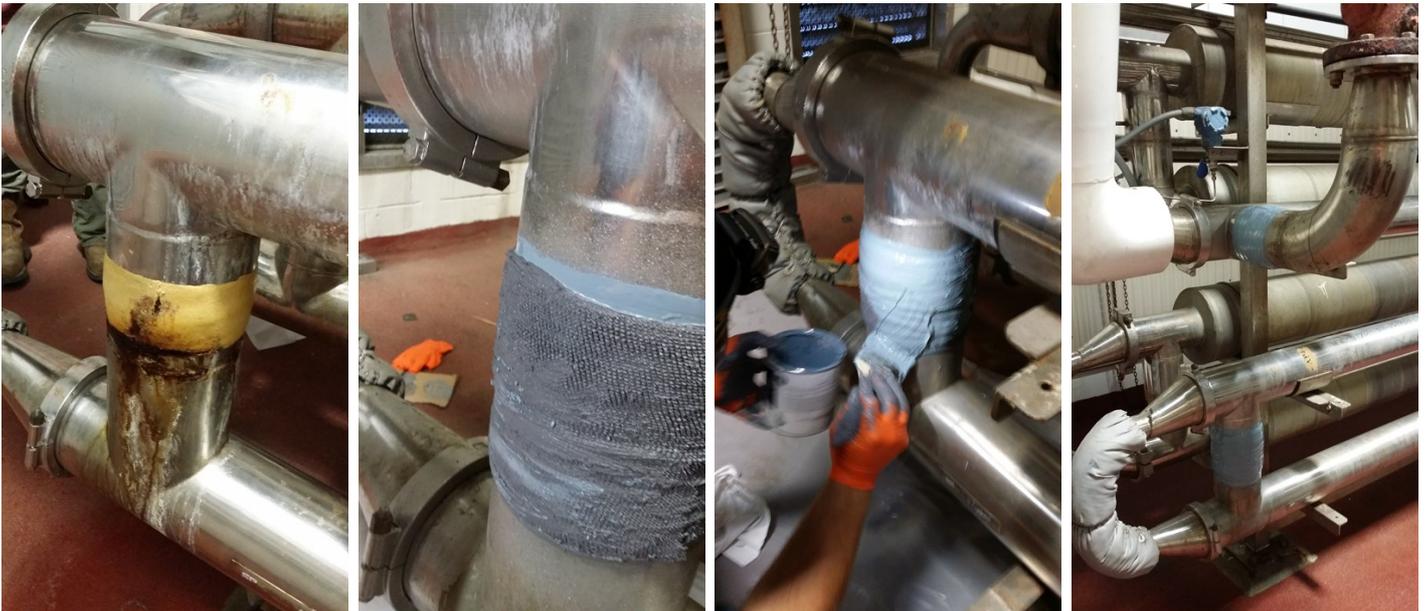
## Photograph Descriptions

Stress crack corrosion leaking hot water out of the pasteurization pipes onto other pipes and machinery.

- \* 1. Previously failed fiberglass wrap ,
- \* 2. Belzona 1511 wrapped over the 1st coat of Belzona 1391T ,
- \* 3. Applying the final coat of Belzona 1391T ,
- \* 4. Two of the four pipes with Belzona solution ,

Client called with an ongoing issue of leaking hot water from stress crack corrosion on stainless steel pasteurization pipes. The previous solution, a fiberglass wrapped system, failed after a month of operation. The surface temperature range from 175°F to 250°F max.

The repair was carried out in accordance with a modified version of Belzona Know-How System Leaflet HEX-9. Belzona 1391T was applied by brush onto the blasted substrate. The reinforcement sheet was wetted out with Belzona 1511 (Super HT-Metal). 3 wraps were required to wrap the pipe and to make sure the first coat of Belzona 1391T was well embedded into the substrate. Finally, the second coat of Belzona 1391T was applied by brush.
