Oxygenation Tank Rebuilt and Protected for Years to Come

ID: 7642

Industry: *Water / Wastewater*
Application: *TCC-Tanks and Chemical Containment Areas*

Customer Location: *Florida, USA*
Application Date: *March 2017*

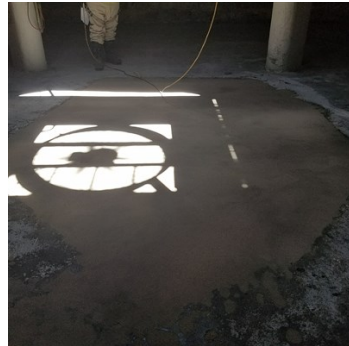
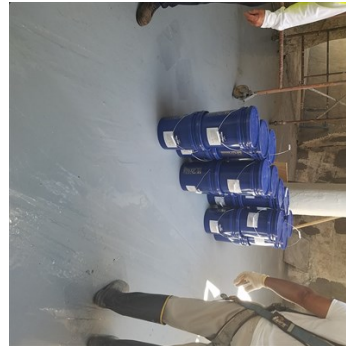
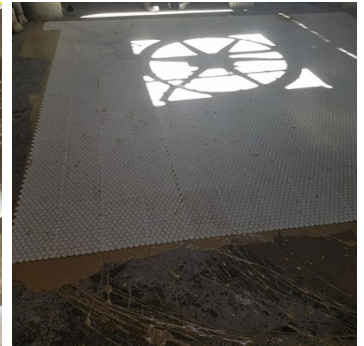
Photograph Descriptions

The tank had not had protection for years, and as a result the concrete walls and floors were in a bad shape. Some sections showed erosion as deep as 3'. Large mixer blades had caused a severe erosion the tanks' structure. The time was of the essence because of the rainy season.

- * Damaged Concrete. ,
- * Concrete rebuilt with Belzona 4124. ,
- * Concrete coated with Belzona 5811. ,
- * Belzona Alumina Tiles System installed: Belzona 5811 as a base coat, Belzona 9811 and Belzona 1812 (as a grouting compound). ,

The application was carried out in accordance with modified versions of Belzona Know-How System Leaflets TCC-9 and TCC-15. First, the damaged concrete areas were rebuilt with Belzona 4124. Once the surfaces were restored, they were coated with Belzona

5811. Then, Belzona 9811 alumina tiles sheets were placed on top of Belzona 5811, and grouted with Belzona 1812.
