BELZONA SAVES A LARGE HOT WATER TANK AT A MEDICAL FACILITY

ID: 7646

Industry: Buildings & Structures
Application: TCC-Tanks and Chemical Containment Areas
Substrate: Carbon steel
Products: * Belzona 5892 ,

Customer Location: Florida, USA
Application Date: May, 2017

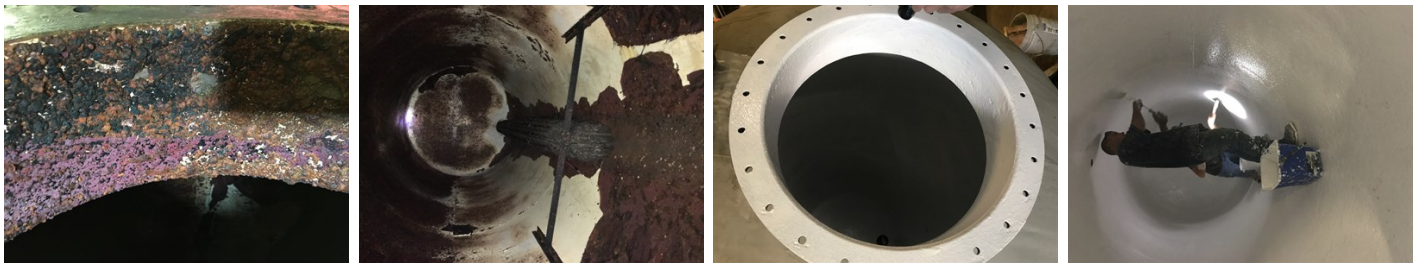
Photograph Descriptions

The original tank was very rusted and the original coating was mostly worn off. They didn't even know if the tank could be saved but were willing to try a new coating system. This facility has many residents and they were afraid the tank would fail and there would not be any money budgeted to get a new tank as quickly as they would need it. This was the only tank they had for this purpose.

- * 1. Rim before Belzona restoration. ,
- * 2. Inside tank before restoration. ,
- * 3. Rim after restoration. ,
- * 4. Inside tank during final coat. ,

The tank was grit blasted with Black Beauty to Belzona's standards. Then two coats of the 5892 were applied. Belzona 5892 was chosen because it could withstand high temperature and could be put back into service quickly. The application was done in accordance with a midified version of Belzona System Leaflet TCC-5.
