# 4311 COATS A SULFURIC ACID TANK AT A CHEMICAL PLANT

ID: 7648

**Industry:** General Industry  
**Application:** TCC-Tanks and Chemical Containment Areas  
**Substrate:** Carbon steel.  
**Products:** \* Belzona 4311 (Magma CR1) ,

**Customer Location:** Northern Florida  
**Application Date:** October 2017

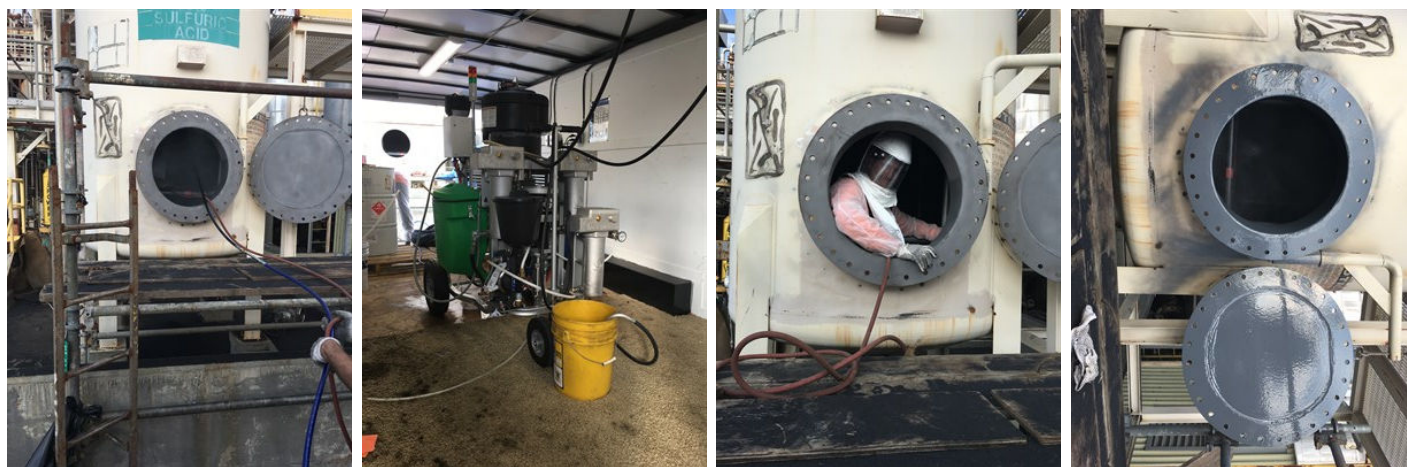
Chemical attack onto the metal was taking a toll. The area was hard to shut down due to the need for this product during production.

- \* 1. This is the tank after blasting with Black Beauty to get the required Belzona cleanliness standard. ,
- \* 2. This shows the pump they used. ,
- \* 3. The spray team about to start. ,
- \* 4. Finished application of 4311. ,

The contractor used a heated plural component pump to do the application as per Belzona's spray instructions. The application was done in accordance to Belzona system leaflet TCC-5.
