4311 COATS A SULFURIC ACID TANK AT A CHEMICAL PLANT

ID: 7648

Industry: General Industry
Application: TCC-Tanks and Chemical Containment Areas
Substrate: Carbon steel.
Products: * Belzona 4311 (Magma CR1) ,

Customer Location: Northern Florida
Application Date: October 2017

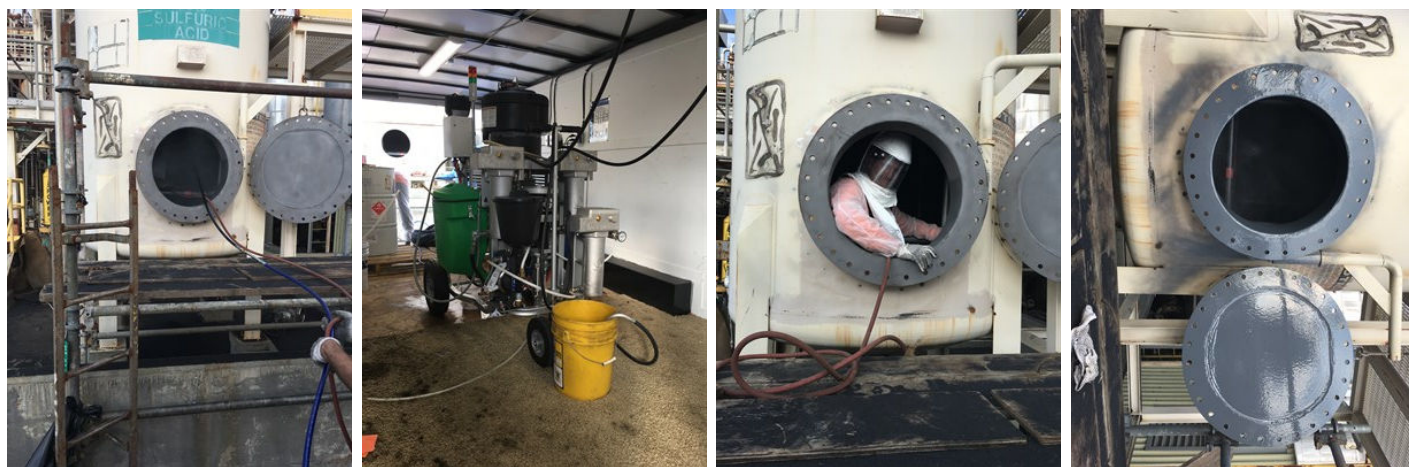
Photograph Descriptions

Chemical attach onto the metal was taking a toll. The area was hard to shut down due to the need for this product during production.

- * 1. This is the tank after blasting with Black Beauty to get the required Belzona cleanliness standard. ,
- * 2. This shows the pump they used. ,
- * 3. The spray team about to start. ,
- * 4. Finished application of 4311. ,

The customer wanted to coat a previously uncoated Sulfuric Acid tank.

The contractor used a heated plural component pump to do the application as per Belzona's spray instructions. The application was done in accordance to Belzona system leaflet TCC-5.
