BELZONA REPAIRS VULCANIZED RUBBER LINED PUMP

ID: 765

Customer Location: *Chemical Plant, Italy*
Application Date: *April 2006*

Substrate: *Vulcanized rubber*
Products: *Belzona® 2111 (D&A Hi-Build Elastomer)*

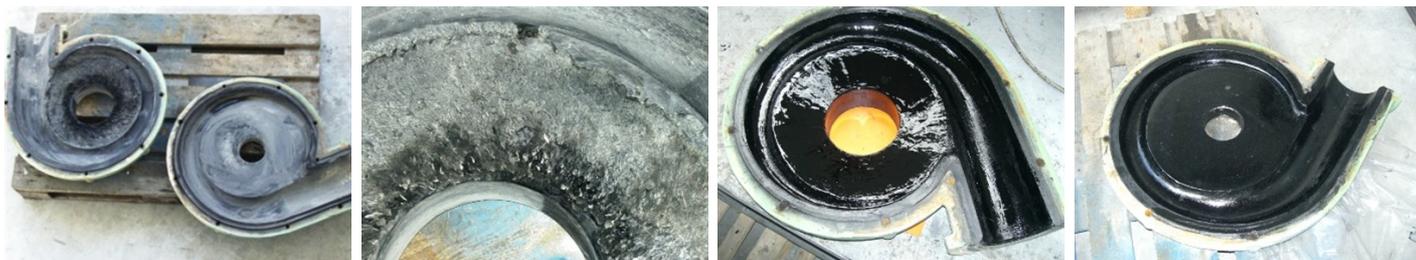
A large area of the rubber had been eroded away.

* Pump body before application , * Close up of damaged rubber , * Upper body after application , * Lower body after application ,

Vulcanized rubber lined pump body

The application was carried out in accordance with Belzona System Leaflet SHM-11.

Belzona Elastomer outlasted the original rubber and allowed localized repairs to be carried out on site without having to return the pump for re-vulcanizing.
