BELZONA GIVES A NEW LIFE TO A PAPER MILL PUMP

ID: 7650

Industry: Pulp & Paper
Application: CEP-Centrifugal Pumps
Substrate: Cast Iron
Products: * Belzona 1311 (Ceramic R-Metal) ,
* Belzona 1321 (Ceramic S-Metal) ,

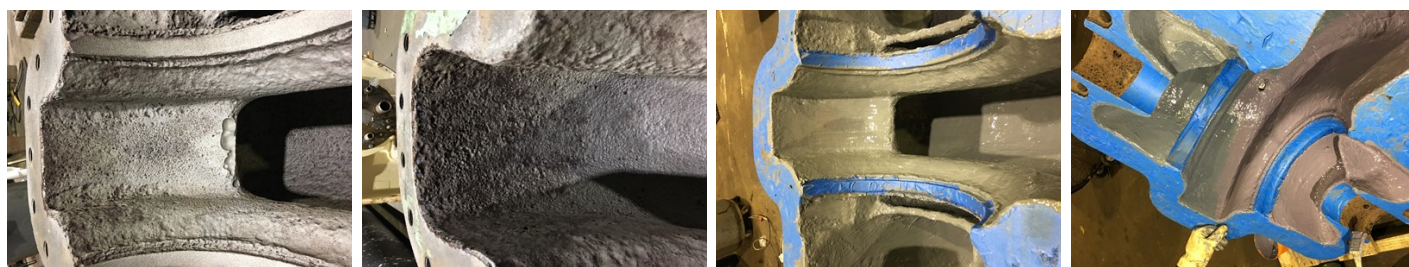
Photograph Descriptions

The interior of the pump metal was severely pitted and the efficiency was compromised. This pump was slated to be scrapped because it was in a bad shape. The replacement pump did not arrive in time so the decision was made to try to salvage this pump using Belzona.

- * 1. Pitting and degradation of the pump after it was blasted with Black Beauty. ,
- * 2. Before the product application ,
- * 3. The metal rebuilt and coated ,
- * 4. Two coats of Belzona 1321 applied over Belzona 1311. ,

Substrate was grit blasted with Black Beauty and then following the Manufacturer's Instructions for Use, a Belzona applicator was used to apply Belzona 1311 to rebuild and smooth out the damaged metal substrate. Belzona 1321 was then applied by a stiff bristle brush in two coats. The application was carried out in accordance with Belzona System Leaflets CEP-3 and CEP-5.
