BELZONA SUPERWRAP II SEALS THROUGH CRACKS ON A 90 DEGREE FLANGE FOR A CHILLER PUMP

ID: 7654

Industry: Fluid Flow
Application: CEP-Centrifugal Pumps
Substrate: Cast Iron
Products: * Belzona 1111 (Super Metal) ,
* Belzona Superwrap II ,

Customer Location: Florida, USA
Application Date: Summer, 2017

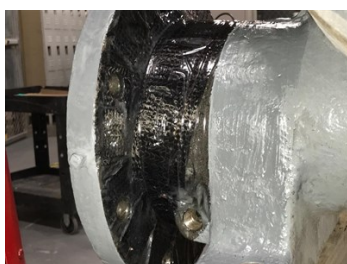
The Customer attempted to repair the cracks. However, leaks still existed after the pump was reinstalled onto the chiller return line and tested. The new solution of Belzona Superwrap II was suggested for the 90 degree flange.

- * 1. Customer's attempted repair. ,
- * 2. Superwrap II application on the outside of the flange. ,
- * 3. Superwrap II application on the inside of the flange. ,
- * 4. Pump reinstalled and working after 4 months of operation nonstop and still working with no leaks. ,
