# LIFT STATION RESTORATION WITH BELZONA 1321

ID: 7659

Application: CEP-Centrifugal Pumps

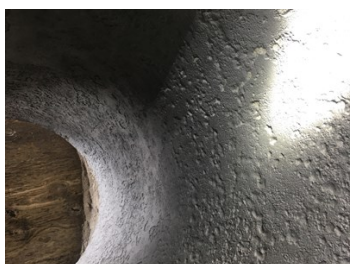
- \* After grit blasting, the cast iron pipes were very rough. ,
- \* The GC crew learned how to mix and apply Belzona products. ,
- \* Three pipes in the back wall, one in the side wall. ,
- \* One pipe finished. ,

The application was carried out in accordance with CEP-3. First, the pipes were grit blasted with Black Beauty. Belzona 1111 was applied to smooth out the rough cast iron and Belzona 1321 was applied in two coats. The Manufacturer's Instructions for Use were strictly followed.
