# Belzona 4311 Protects a Nitric Acid Loading Area at a Chemical Plant

Customer Location: Chemical Plant, Florida, USA

Application Date: October 2017

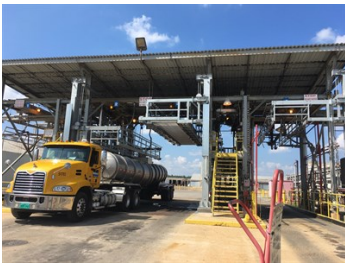
- \* 1. Trucks unloading nitric acid ,
- \* 2. Belzona 4311 applied. ,
- \* 3. Belzona 4311 applied. ,
- \* 4. Belzona 4311 applied. ,

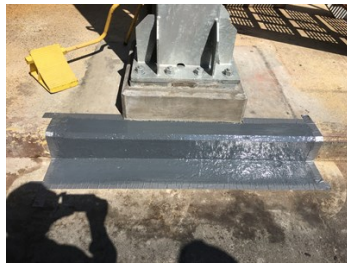
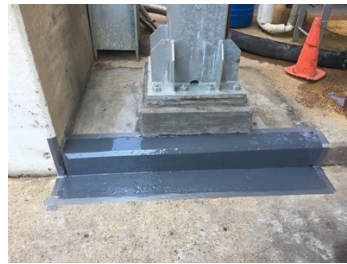
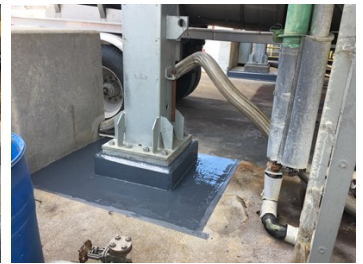
## Problem

There was a General Contractor that would re-build the curbs and piers that were degraded. They have used Belzona in the past and the Belzona consultant also worked with them on the application. The substrate was thoroughly cleaned and allowed to dry. A coat of Belzona 4911 was first put down as the substrate was too porous due to the chemical attack and adhesion of Belzona 4311 system (2 coats) over the top was to be maximized.
