Belzona Granogrip System Provides Safety at a Medical Facility

Application: FPA-Floor Problem Areas

Customer Location: Medical Facility, Washington, USA

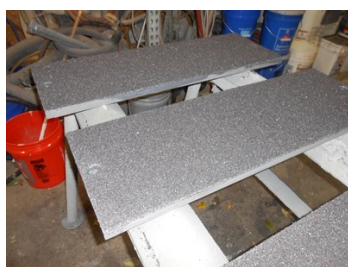
- * 1. Open grate - safety hazard. ,
- * 2. Twelve steel plates after being grit blasted in a mashine shop. ,
- * 3. & 4. Sidewalk drain covers in place. ,

New construction of a medical facility. The plans called for open grates over the sidewalk drains. The building inspector rejected the open grates as a safety hazard, especially for high heel shoes.

Determining that the open grates would be a safety hazard and untreated steel would be a slip hazard the engineers called Belzona for a solution. Samples were sent to the building inspector and he chose Belzona 4411 GranoGrip with Belzona 9211 Aggregate.
