Belzona Applies a Protective System on a Grit Snail

ID: 7671

Industry: Water / Wastewater

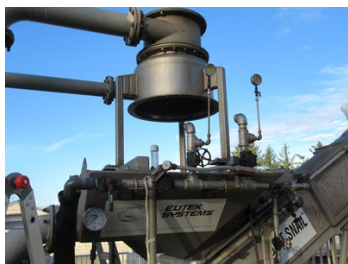
- * 1. Grit Snail ,
- * 2. Worn area inside grit bowl. ,
- * 3. & 4. Belzona 1811 (Ceramic Carbide) replaced. ,

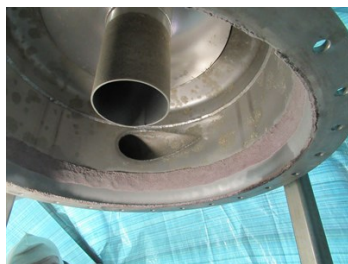
Grit running through the grit removal system wears through the protective coating and the stainless steel housing.

The grit removal system, called a Grit Snail, in a waste water treatment plant malfunctioned. The timer had quit working causing the Grit Snail to run constantly causing the factory installed sacrificial coating to wear prematurely through the coating in to the stainless steel housing.

The stainless steel and remaining Belzona 1811 are grit blasted. The 1811 is mixed and applied 1/4" thick on the edges and slightly thicker in the center.

The Grit Snail manufacturer applied a 6" wide band of 1811 in the wear area of the grit bowl. It is a sacrificial coating and must be renewed from time to time. Replacement bowls are quite expensive, thus having a protective coating that extends the service life of the equipment is ideal
