# Belzona SuperWrap II Salvages Sewage Treatment Plant

ID: 7673

Industry: Water / Wastewater  
Application: VPF-Valves, Pipes and Fittings  
Substrate: Carbon Steel  
Products: \* Belzona SuperWrap II System ,

Customer Location: France  
Application Date: 2017

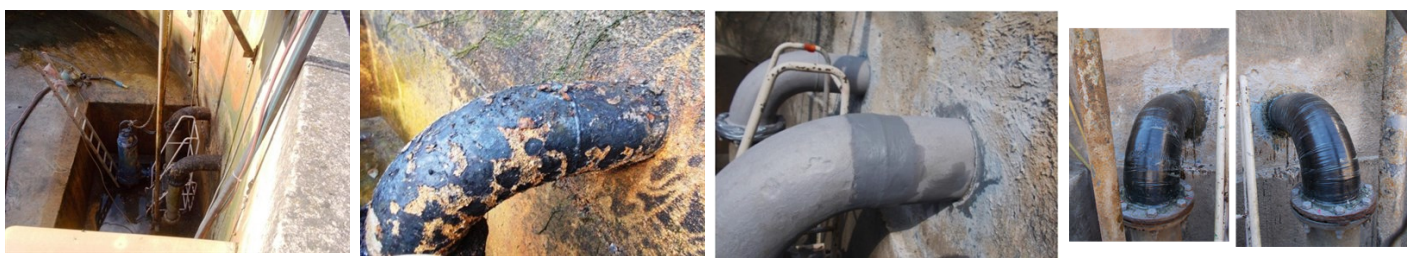
Carbon steel pipe elbows have been suffering over time from external corrosion due to weathering. The Customer required the restoration of metal loss on both pipes whilst adding further protection against future corrosion. The Customer was interested in a compliant composite solution to repair by reinstating the pipe's strength and to protect the pipework from further corrosion.

- \* 1. Corroded pipework ,
- \* 2. Extensive corrosion leading to through wall defects ,
- \* 3. Surface was prepared via grit blasting ,
- \* 4. Finish application ,

The application was carried out in accordance with a modified Belzona Know-How System leaflet VPF-11 for repairing leaks in pipes. The pipework was offline. Three wraps (6 layers) of Belzona SuperWrap II were applied to the repair area according to the design, specifically created for this application.
