# Belzona Keeps US Navy Fire Pump Ready to Run

ID: 7675

Industry: Marine  
Application: CEP-Centrifugal Pumps  
Substrate: Brass  
Products: \* Belzona 1111 (Super Metal) ,  
\* Belzona 1341 (Supermetalglide) ,

Customer Location: Washington, USA  
Application Date: February 2017

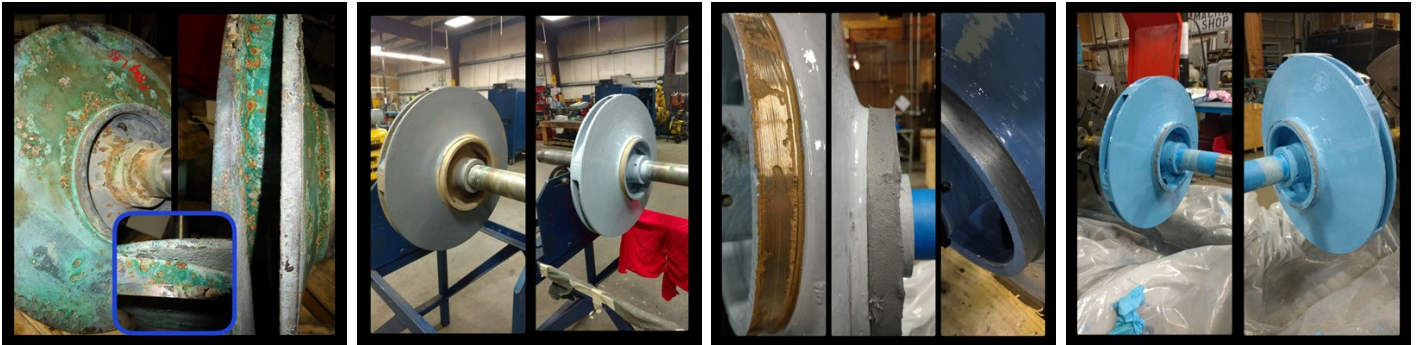
*Due to lack of frequent use, this fire pump onboard a US Navy ship sits for extended amounts of time with sea water inside of it causing severe corrosion. This makes the fire pump potentially unreliable in case of an emergency.*

- \* 1. Original condition of the impeller. ,
- \* 2. Belzona 1111 applied to rebuild the damage. First coat of Belzona 1341 applied ,
- \* 3. Belzona 1111 rebuilding the wear rings. ,
- \* 4. Completed application, ready for re-assembly. ,

Fire pump impeller on-board a US Navy ship.

Grit blasted to achieve a 3-5 mil profile, and coated with Belzona 1111 to fill in and rebuild the pitting and damage to a smooth clean finish. Allowed to firm up, and then overcoated with the first coat of Belzona 1341. The impeller wear ring was also heavily corroded and was machined down to a rough thread pattern and overbuilt with Belzona 1111 at this time. While waiting for the wear ring application to solidify, the second coat of Belzona 1341 was applied. Finally, the wear ring surface was machined back to the original specifications.

This impeller would have had to be replaced, but with Belzona materials being used, repairing it only cost a couple hundred US

dollars without risking heat distortion by welding on it. The added bonus is an increase in efficiency whenever the pump is operated.
