# Belzona SuperWrap II Sets Sail

Industry: *Marine*  
Application: *SOS-Ships and Offshore Structures*

Substrate: *Carbon Steel*  
Products: *\* Belzona SuperWrap II System ,*  
*\* Belzona 1321 (Ceramic S-Metal) ,*

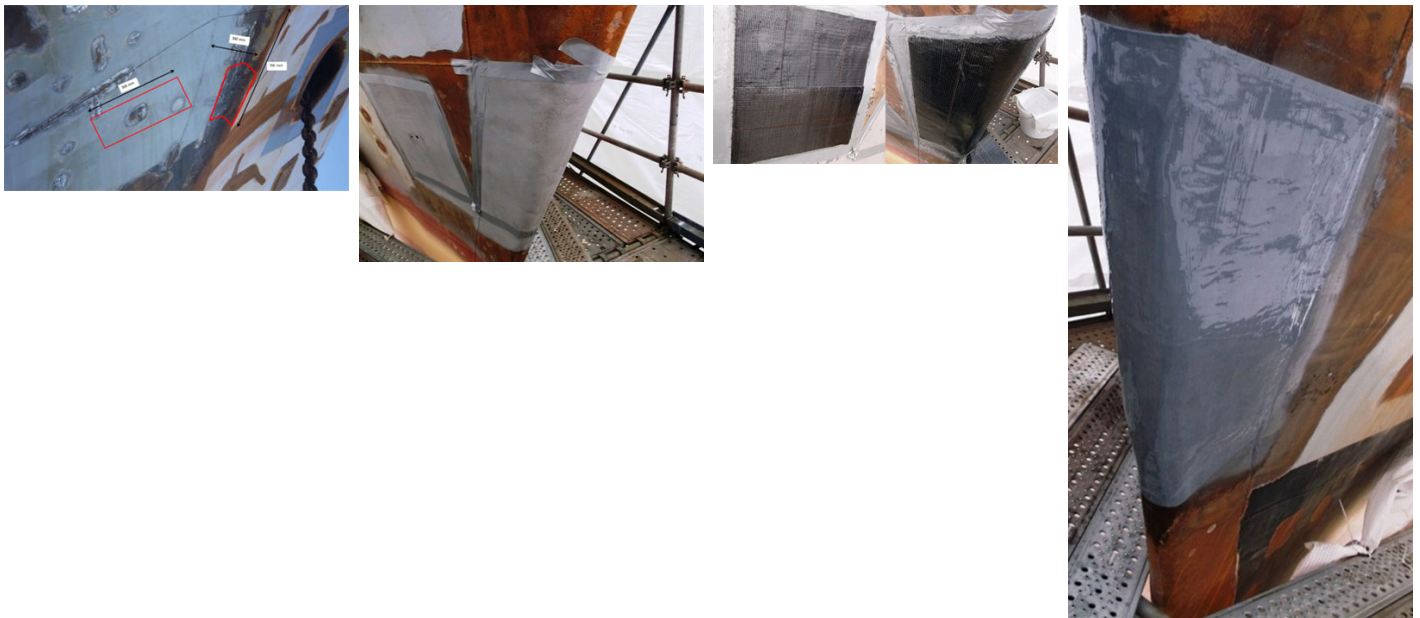
*Loss of steel, leading to thin walling on the boat's hull. This damage has occurred due to corrosion within the marine environment. The asset owner was looking for a solution to reinstate the metal loss and provide long lasting protection against the harsh environment at sea.*

- \* 1. Areas on the boat hull to be repaired. ,
- \* 2. Application areas prepared via abrasive blasting. ,
- \* 3. Belzona SuperWrap II patches applied. ,
- \* 4. Finished application coated with Belzona 1321. ,

The application was carried out in accordance with a modified version of Belzona System Leaflet SOS-2. Once the areas that required repair were established and prepared via abrasive blasting, a patch repair manufactured using the Belzona SuperWrap II system, was then applied before being overcoated by Belzona 1321 (Ceramic S-Metal).

The SuperWrap II patch was specifically designed for this application to provide a cost-effective and long lasting corrosion barrier to the boat's hull, just above the waterline. The asset owner was extremely happy that the Belzona solution provides outstanding corrosion protection without the need of hot work, increasing the ease of application.
