# BELZONA REFURBISHES ENTRANCE STEPS OUTSIDE A MUNICIPAL BUILDING

ID: 7683

Application: FPA-Floor Problem Areas

Substrate: Concrete

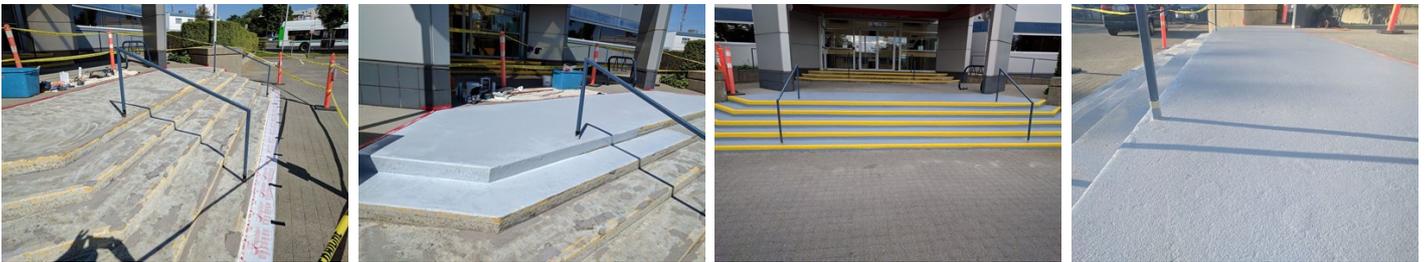
## Photograph Descriptions

The entrance steps were looking "tired" and needed to be repaired and re-coated.

- \* 1. The original coating removed ,
- \* 2. A full coat of Belzona 5231 (SG Laminate) in light grey applied to the prepared surface, saturated with Belzona 9232 (Lt Grey Quartz Aggregate) and over-coated with Belzona 5233. ,
- \* 3. All stair tread edges were highlighted with safety yellow. ,
- \* 4. Close up of completed stair surface. ,

The application was carried out in accordance with Belzona Know-How System Leaflet FPA-1. The original coating was removed using a Vacu-Grinder and the damaged areas rebuilt with Belzona® 4111 (Magma Quartz). A full coat of Belzona® 5231 (SG Laminate) (Lt Grey) was applied to the prepared surface and saturated with Belzona® 9232 (Lt Grey Quartz Aggregate) and over-coated with Belzona 5233 in Grey. All stair tread edges were highlighted with safety yellow.
