OLD PUMPS REPAIRED, PROTECTED AND IMPROVED WITH BELZONA

ID: 7685

Customer Location: Dry Dock Facility, BC, Canada
Application Date: August 2017

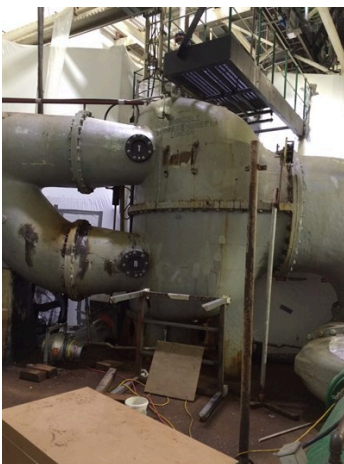
- * 1. 30 ft high pump. ,
- * 2. Showing damage from erosion-corrosion. ,
- * 3. Application of Belzona 1341 Blue in progress. ,
- * 4. Complete application. ,

Pumps housing building at a Canadian historic site. 30 ft high pumps.

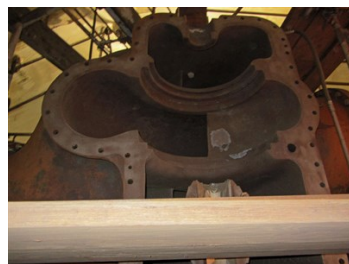
The pumps were damaged by erosion-corrosion due to the salt content in the water they were pumping. Holes had developed in some of the cast iron casings and stuffing boxes also needed major rebuilding. Although the pumps were old, replacing them was not possible.

The application was carried out in accordance with modified versions of Belzona Know-How System Leaflets CEP-1 and CEP-3. Belzona 1121 was used to rebuild and repair the eroded surfaces. Belzona 1341 was used to improve the pumps performance. Due to the large size of the pumps and related inlets and outlets, it was decided to blast in stages and then protect with Belzona 1341. This was followed by a skim coat of Belzona 1341/1121 mixture to fill in most of the lower depressions. The remaining voids were filled with Belzona 1121. The units received a final brush blast before 2 successive coats of Belzona 1341 grey and blue were
