BELZONA 3111 SUCCESSFULLY HANDLES AN INTRICATE DESIGN OF A CHURCH DOME-SHAPED ROOF

Industry: *Buildings & Structures*
Application: *RPA-Roof Problem Areas*
Substrate: *Metal*

Customer Location: *Church, Virginia, USA*
Application Date: *September 2017*

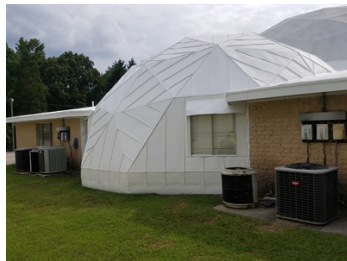
- * 1. Image of the original roof repair back in 1980s. ,
- * 2. View of one of the domes, showing intricates of the roof design. ,
- * 3. Complete application. ,

The entire roof area was pressure washed. All the metal repairs were conducted using Belzona 1121. Belzona 3921 was applied to two (2) areas – each 20' x 40' and one (1) area – 15' x 40' and over metal repair areas. During the overcoat window of Belzona 3921, Belzona 3111 in white was applied at 10 mils thick. Belzona 9311 was wetted out and fully embedded into the base layer of Belzona 3111. Within the overcoat window of the base coat of Belzona 3111, a top layer of Belzona 3111 in white was applied at 6 mils thick.
