BELZONA 3111 SUCCESSFULLY HANDLES AN INTRICATE DESIGN OF A CHURCH DOME-SHAPED ROOF

ID: 7687

Customer Location: *Church, Virginia, USA*
Application Date: *September 2017*

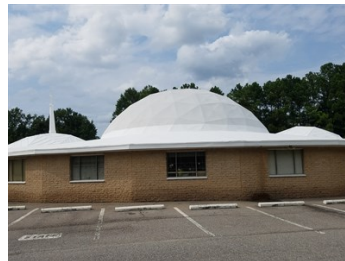
- * 1. Image of the original roof repair back in 1980s. ,
- * 2. View of one of the domes, showing intricates of the roof design. ,
- * 3. Complete application. ,

A church building with geodesic foam and wood truss dome structure that is built on ground that has a great deal of movement.

The entire roof area was pressure washed. All the metal repairs were conducted using Belzona 1121. Belzona 3921 was applied to two (2) areas – each 20' x 40' and one (1) area – 15' x 40' and over metal repair areas. During the overcoat window of Belzona 3921, Belzona 3111 in white was applied at 10 mils thick. Belzona 9311 was wetted out and fully embedded into the base layer of Belzona 3111. Within the overcoat window of the base coat of Belzona 3111, a top layer of Belzona 3111 in white was applied at 6 mils thick.
