BELZONA 3111 SUCCESSFULLY HANDLES AN INTRICATE DESIGN OF A CHURCH DOME-SHAPED ROOF

ID: 7687

Industry: *Buildings & Structures*
Application: *RPA-Roof Problem Areas*
Substrate: *Metal*

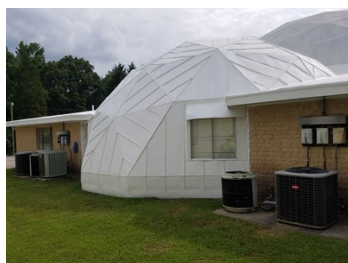
- * 1. Image of the original roof repair back in 1980s. ,
- * 2. View of one of the domes, showing intricates of the roof design. ,
- * 3. Complete application. ,

The entire roof area was pressure washed. All the metal repairs were conducted using Belzona 1121. Belzona 3921 was applied to two (2) areas – each 20' x 40' and one (1) area – 15' x 40' and over metal repair areas. During the overcoat window of Belzona 3921, Belzona 3111 in white was applied at 10 mils thick. Belzona 9311 was wetted out and fully embedded into the base layer of Belzona 3111. Within the overcoat window of the base coat of Belzona 3111, a top layer of Belzona 3111 in white was applied at 6 mils thick.
