BELZONA EXPANSION JOINT REPAIR HELPS A COAL MINE STAY ENVIRONMENTALLY COMPLIANT

Customer Location: *Coal terminal, Alabama, USA*
Application Date: *2017*

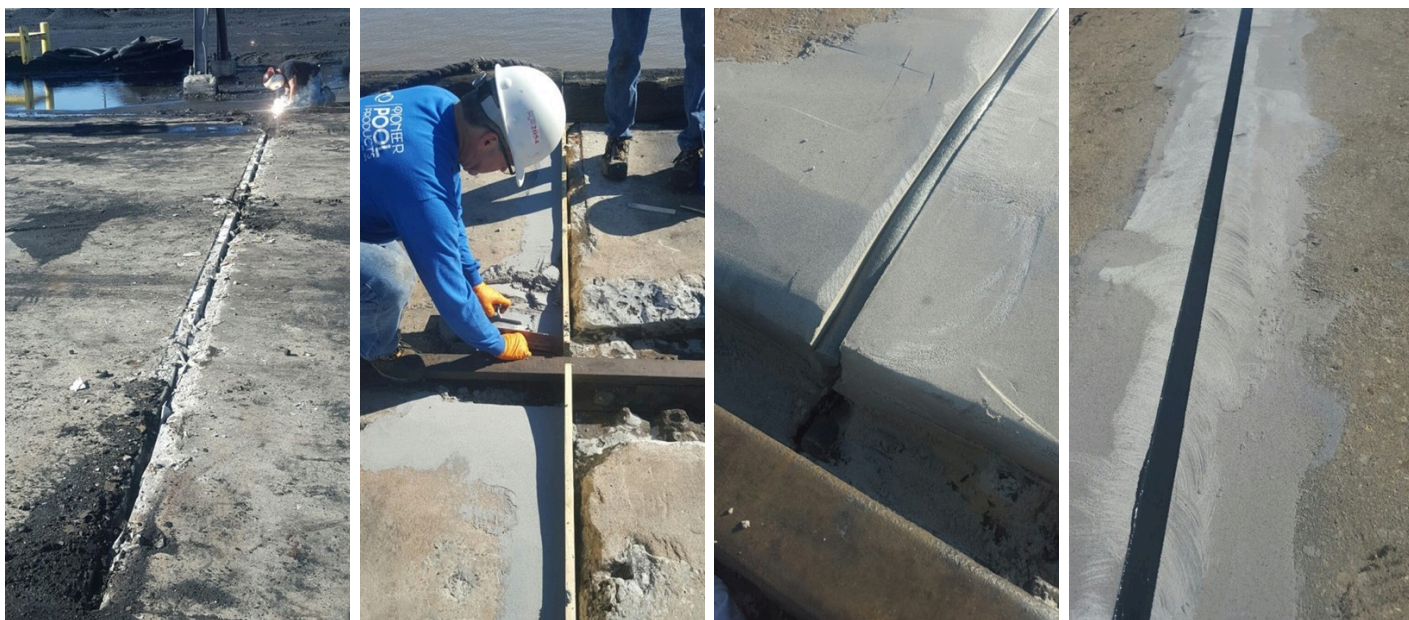
Photograph Descriptions

The existing rubber expansion joint material failed to stop coal from falling through the concrete dock and into the Bay waters, causing a potential environmental hazard.

* 1. Removal of nosing and damaged concrete. 2. Concrete restoration of Belzona 4131. 3. Backer rod inserted prior to an application of Belzona 2211. 4. Expansion joint repair complete. ,

The repair area was pressure washed to remove all coal dust in and around the joint. Then, the metal nosing, all old rubber and other previously used joint materials were removed and the concrete areas were re-cleaned. Concrete areas were leveled by means of manual grinding. Belzona 4131 was used to build up the damaged concrete. Once Belzona 4131 was applied, this area was not accessible for any traffic until the following day, when Belzona 2211 was mixed and applied with the use of form boards and a backer rod.
