# BELZONA'S CREATIVE APPROACH SAVES A REFINING COMPANY A LARGE LOSS IN REVENUE

ID: 7689

Customer Location: Refinery, Texas, USA  
Application Date: 2017

A 30" return line for a cooling tower.

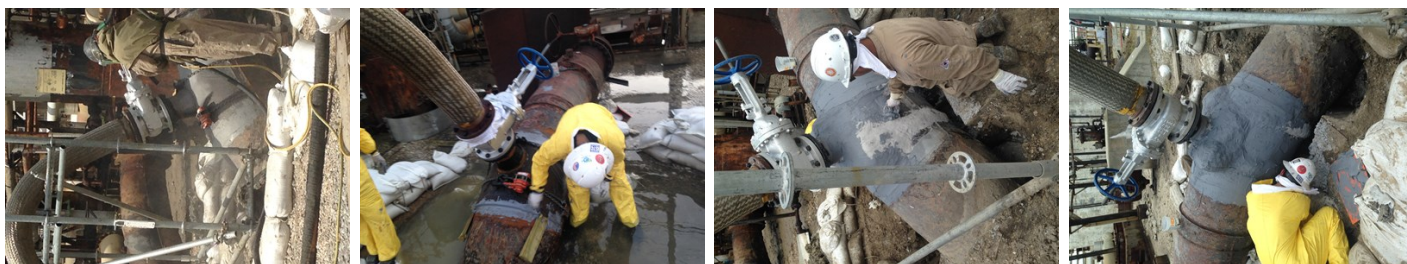
## Photograph Descriptions

The water line had a welded patch fail. The line was leaking approx. 20 plus feet in the air and 40 feet across a road. The line was losing so much water that they were unable to perform a back flush of the cooling tower. Shutting the line down would result in a plant wide shut down at a cost of 1M dollars a day.

- \* 1. Half wrap being blasted and prepped to have a wrap applied. ,
- \* 2. Belzona 1161 being applied. ,
- \* 3. Belzona 4141 applied to the come-alongs and chain and Belzona 1121 applied over Belzona 4141. ,
- \* 4. Applying the top layer of Belzona 1321 to encapsulate the repair. ,

Access to the repair was difficult due to several feet of gravel that had to be removed to get access underneath the pipe. The pipe was grit blasted in the application area. By use of a mini excavator, a fully assembled half wrap was positioned (Valve attached and seal on the underneath side) over the hole. Two chain come-alongs were put around the pipe and half wrap to hold down the half wrap and create a water tight seal around the neoprene seal. The neoprene seal left a 1 and 1/4 gap in-between the half wrap and

the pipe. Belzona 1161 was pushed in this gap from all sides until each side was filled. This was left to cure for a couple of days with the chain come-alongs left in place. A hose was connected to the gate valve to direct the lost water back to the cooling tower so that they could perform back flush procedures. Belzona 4141 was used to encapsulate the come-alongs and performed a wrap procedure with Belzona 1121 and Belzona 9341 to encapsulate the come-alongs. We then applied a layer of 1321 on top of the wrap for added protection.
