# BELZONA COLD BONDING REPAIRS AN EXHAUST FLUE

**Industry:** Steel & Metal Processing

**Customer Location:** Zinc and Lead Smelting Complex, BC,  
Canada

**Application:** VPF-Valves, Pipes and Fittings

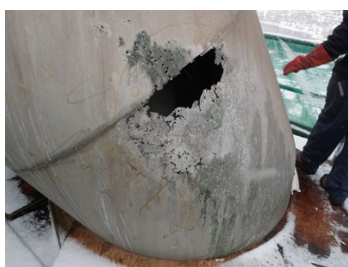
A hole was created in the wall of the flue at an elbow; due to the location of the hole, it was not noticed until it was nearly one foot across. Upon closer inspection, it was found that a large section of the flue wall in this area was pitted and weakened, with many small holes developing.

View of small holes indicating extensive pitting of the interior surface

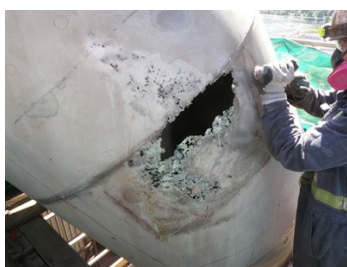
Initial surface preparation using a wire brush

Patch plates were pre-designed to fit the flue elbow, and blasted prior to the application. The application was performed from scaffolding with flue in operation. Surface preparation was limited due to the necessity of avoiding any sparks which could be drawn into the hole; the use of a hand-held random orbit sander equipped with 40-grit paper was approved, and this was used along with handheld wire brush for prep on the exterior surface of the flue. After prep, the flue exterior surface was coated by brush with Belzona 5841, which is tolerant of both minimal surface prep and the temperatures at which this flue operates, with the aim of improving adhesion of Belzona 1121 to this surface. Belzona 1121 was mixed and applied to the back of the first patch plate to a thickness of approximately 3/4", and this plate was then lifted by two people (using handles welded to the plates for this purpose) and positioned while a third person installed and tightened band clamps to hold the plate in place during cure. Five separate patch plates were installed in sequence, including a strip covering the joint between two adjacent plates.

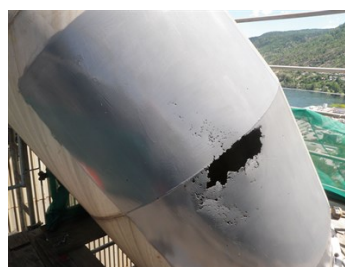
Prepared area coated with Belzona 5841

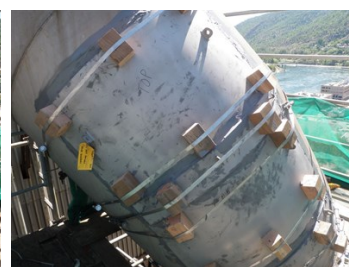
All 5 plates bonded in place; application is completed

The repair was inspected several times since application in June 2017 and was performing perfectly at the time of inspection.
