BELZONA COLD BONDING REPAIRS AN EXHAUST FLUE

Customer Location: Zinc and Lead Smelting Complex, BC, Canada

Application: VPF-Valves, Pipes and Fittings

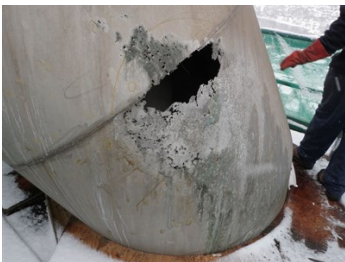
A hole was created in the wall of the flue at an elbow; due to the location of the hole, it was not noticed until it was nearly one foot across. Upon closer inspection, it was found that a large section of the flue wall in this area was pitted and weakened, with many small holes developing.

View of small holes indicating extensive pitting of the interior surface

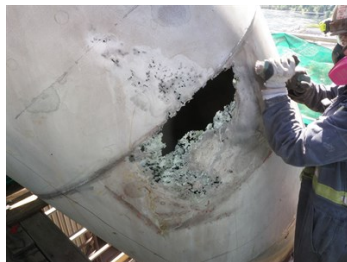
Initial surface preparation using a wire brush

Patch plates were pre-designed to fit the flue elbow, and blasted prior to the application. The application was performed from scaffolding with flue in operation. Surface preparation was limited due to the necessity of avoiding any sparks which could be drawn into the hole; the use of a hand-held random orbit sander equipped with 40-grit paper was approved, and this was used along with handheld wire brush for prep on the exterior surface of the flue. After prep, the flue exterior surface was coated by brush with Belzona 5841, which is tolerant of both minimal surface prep and the temperatures at which this flue operates, with the aim of improving adhesion of Belzona 1121 to this surface. Belzona 1121 was mixed and applied to the back of the first patch plate to a thickness of approximately 3/4", and this plate was then lifted by two people (using handles welded to the plates for this purpose) and positioned while a third person installed and tightened band clamps to hold the plate in place during cure. Five separate patch plates were installed in sequence, including a strip covering the joint between two adjacent plates.

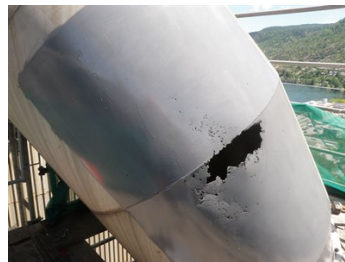
Prepared area coated with Belzona 5841

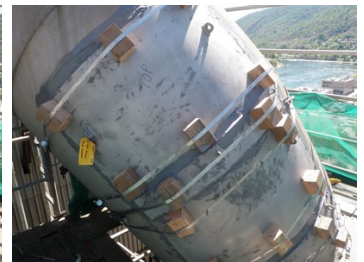
All 5 plates bonded in place; application is completed

The repair was inspected several times since application in June 2017 and was performing perfectly at the time of inspection.
