BELZONA COLD BONDING REPAIRS AN EXHAUST FLUE

Customer Location: Zinc and Lead Smelting Complex, BC,
Canada

Application: VPF-Valves, Pipes and Fittings

Application Date: June 2017

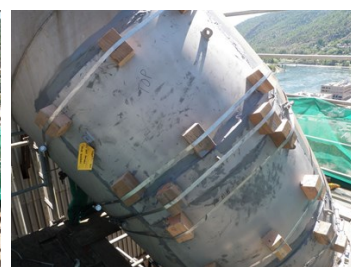
All 5 plates bonded in place; application is completed

Patch plates were pre-designed to fit the flue elbow, and blasted prior to the application. The application was performed from scaffolding with flue in operation. Surface preparation was limited due to the necessity of avoiding any sparks which could be drawn into the hole; the use of a hand-held random orbit sander equipped with 40-grit paper was approved, and this was used along with handheld wire brush for prep on the exterior surface of the flue. After prep, the flue exterior surface was coated by brush with Belzona 5841, which is tolerant of both minimal surface prep and the temperatures at which this flue operates, with the aim of improving adhesion of Belzona 1121 to this surface. Belzona 1121 was mixed and applied to the back of the first patch plate to a thickness of approximately 3/4", and this plate was then lifted by two people (using handles welded to the plates for this purpose) and positioned while a third person installed and tightened band clamps to hold the plate in place during cure. Five separate patch plates were installed in sequence, including a strip covering the joint between two adjacent plates.

The repair was inspected several times since application in June 2017 and was performing perfectly at the time of inspection.
