# GRAND STAIRCASE OF A FUTURE HOME OF A HISTORIC MUSEUM RESTORED WITH BELZONA

ID: 7694

Application: FPA-Floor Problem Areas

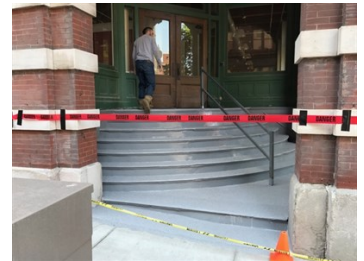
The original build grand staircase made from pre-1920 cast-iron had severe rust and multiple failures. It was a tremendous eyesore and in some areas impassible.

- \* 1. General view of the staircase showing damage. ,
- \* 2. Stair nosings rebuilt with Belzona 1211 and steel rods. ,
- \* 3. Two coats of Belzona 5231 loaded with Surefoot Aggregate on walking treads applied. ,
- \* 4. Belzona 5233 applied as a top coat for UV-stability. ,

The application was carried out in accordance with a modified version of Belzona Know-How System Leaflet FPA-5. Since the application was taking place on a very busy street with heavy foot traffic, a containment area was built to contain the dust from blasting. The substrate was blasted off to bare metal. Once the media blasting was completed, 1/2" iron rods were installed to repair the step noses and cold bond metal plates where the original staircase had corroded away. Then, the entire staircase was coated with Belzona 5231. The second coat was loaded with an anti-slip surefoot aggregate and applied to all walking surfaces. Once Belzona 5231 cured, a topcoat with Belzona 5233 was applied.
