# Belzona Composite Ferry Wrap

ID: 7698

Ferry Pipe

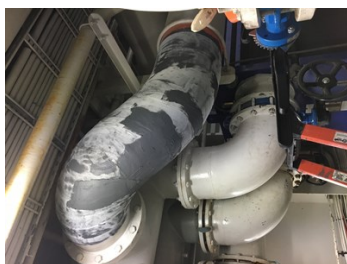
*Suffering from external corrosion*

- \* 1. Damaged pipe ,
- \* 2. Belzona 1121 wrap in progress ,
- \* 3. Composite Wrap complete ,
- \* 4. Completed application ,

The application was carried out in accordance with Belzona system leaflet VPF-11. This was followed by over-coating with Belzona 5821.
