Belzona Supports Effluent Tank

ID: 7699

Damaged concrete supports of effluent water vessel

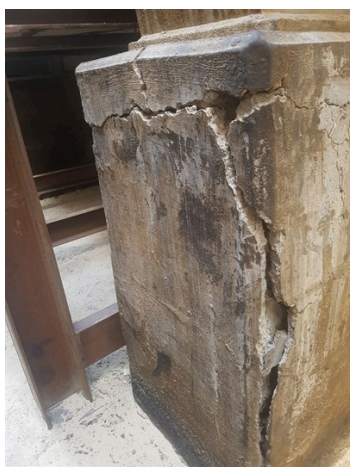
Water ingress and weathering had caused corrosion of the reinforcement bar, leading to cracking and spalling of the concrete supports.

Cracked and Spalling Concrete

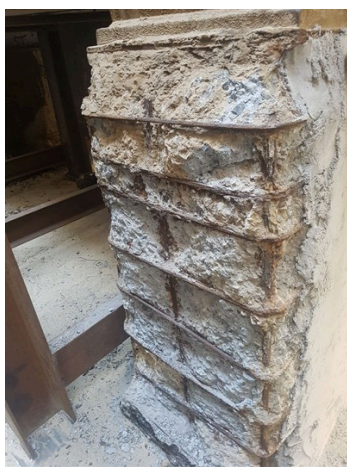
Damaged and loosely adhered concrete removed

Damaged and loose concrete was removed before the surface was abraded using mechanical tools to clean and roughen the surface, and remove corrosion from the reinforcement bar. Compressed air was then used to remove dust. The surface was primed with Belzona 4911, and Belzona 4141 used to rebuild the surface to the original dimensions. For additional protection from weathering and potential spillage from the tank, 2 coats of Belzona 5811 were added to protect the vessel supports.

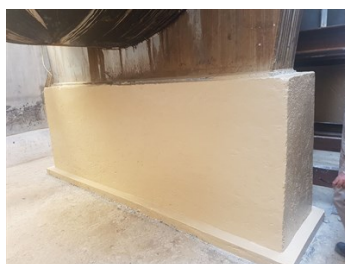
Concrete supports repaired and coated

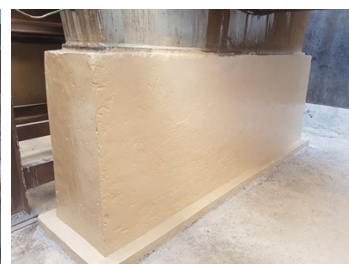
Concrete supports repaired and coated
