Belzona Saves Silo Lid

Customer Location: Bedfordshire, UK

Application: TCC-Tanks and Chemical Containment Areas

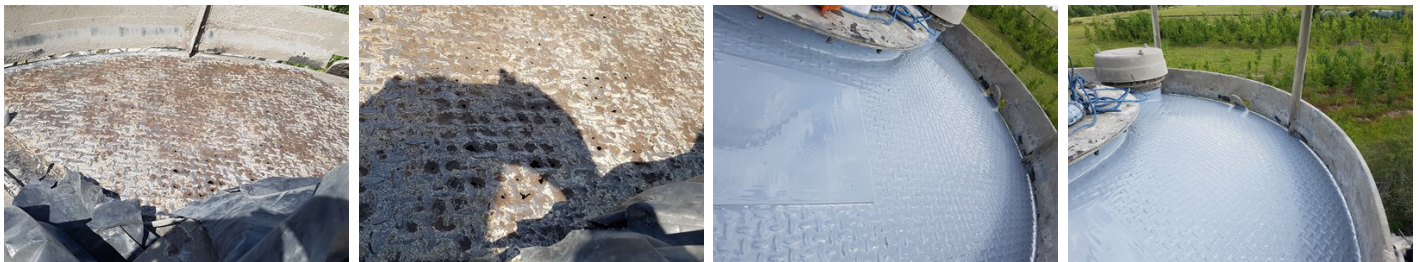
Photograph Descriptions

The customer had noticed problems with their cement storage silo and after inspecting found that the lid was severely corroded and was letting in rainwater. The silo is 11 metres high, to replace the lid would be logistically very difficult and incredibly expensive.

* 1. The silo lid at the start of the repairs 2. A closer look at the damage 3. The lid repaired with B1111 plate bonding techniques 4. The finished lid ,

The lid was cleaned thoroughly using a bristle blaster as grit blasting was not possible at the height required due to logistical and environmental factors. Steel plates were then bonded to the lid using B1111 where required to repair the holed areas using an adapted version of Belzona System Leaflet TCC-3 Once the plates were bonded into place and the B1111 had cured, two coats of B5811 were applied to the silo lid.
