# Belzona Enhances Hospital Steps

ID: 7701

Industry: Buildings & Structures  
Application: FPA-Floor Problem Areas  
Substrate: Sandstone  
Products: \* Belzona 5821 ,  
\* Belzona 9211 (Supergrip Aggregate) ,

Customer Location: Glasgow, UK  
Application Date: March 2018

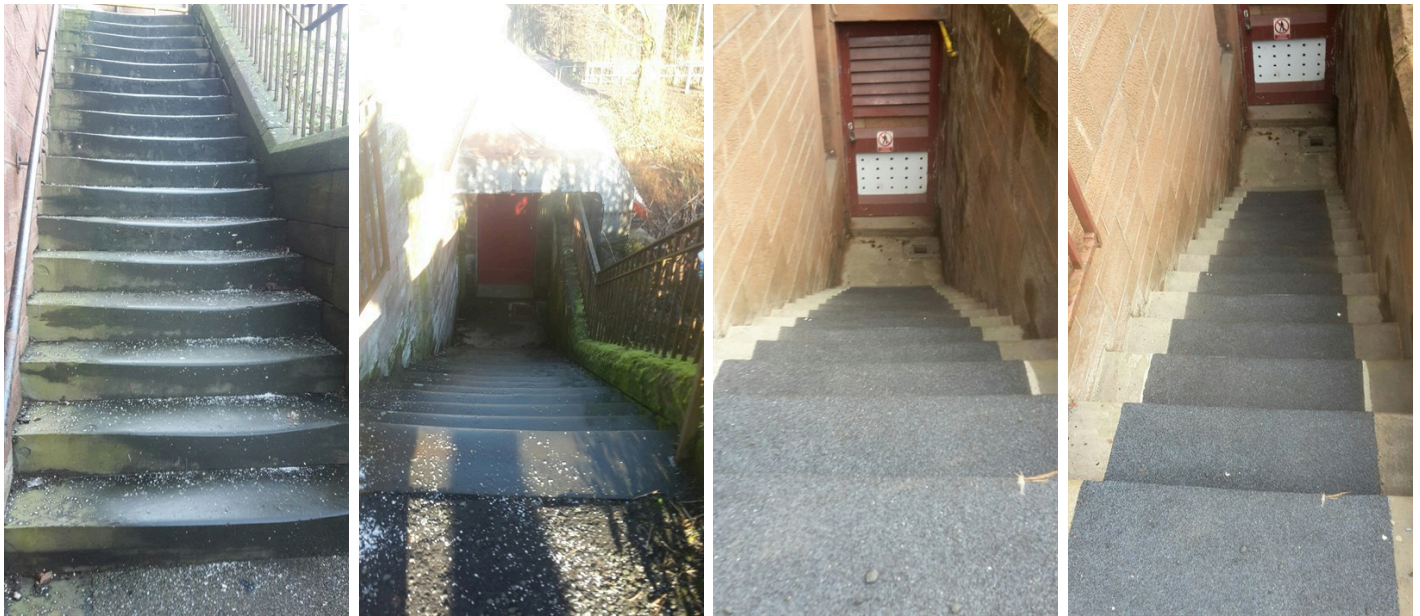
A potential slip hazard had been noted on several sets of sandstone steps. Due to the enclosed area it was often damp or icy in the winter. A durable long lasting solution was required to ensure the slip hazard could not reoccur in the future.

- \* 1- Gritted steps in winter to try and prevent slippages ,
- \* 2- Top down view showing dampness of steps ,
- \* 3- Belzona system applied with 9211 aggregate ,
- \* 4- Completed application ,

Several staircases around a hospital in Glasgow has significantly worn away.

The steps were marked out & prepared using a floor grinder. Belzona 5821 was then applied as a 1 coat system. Immediately following this Belzona 9211 aggregate was blinded into the coating & tamped down.
