Belzona Enhances Hospital Steps

Industry: Buildings & Structures
Application: FPA-Floor Problem Areas
Substrate: Sandstone
Products: * Belzona 5821 ,
* Belzona 9211 (Supergrip Aggregate) ,

Customer Location: Glasgow, UK
Application Date: March 2018

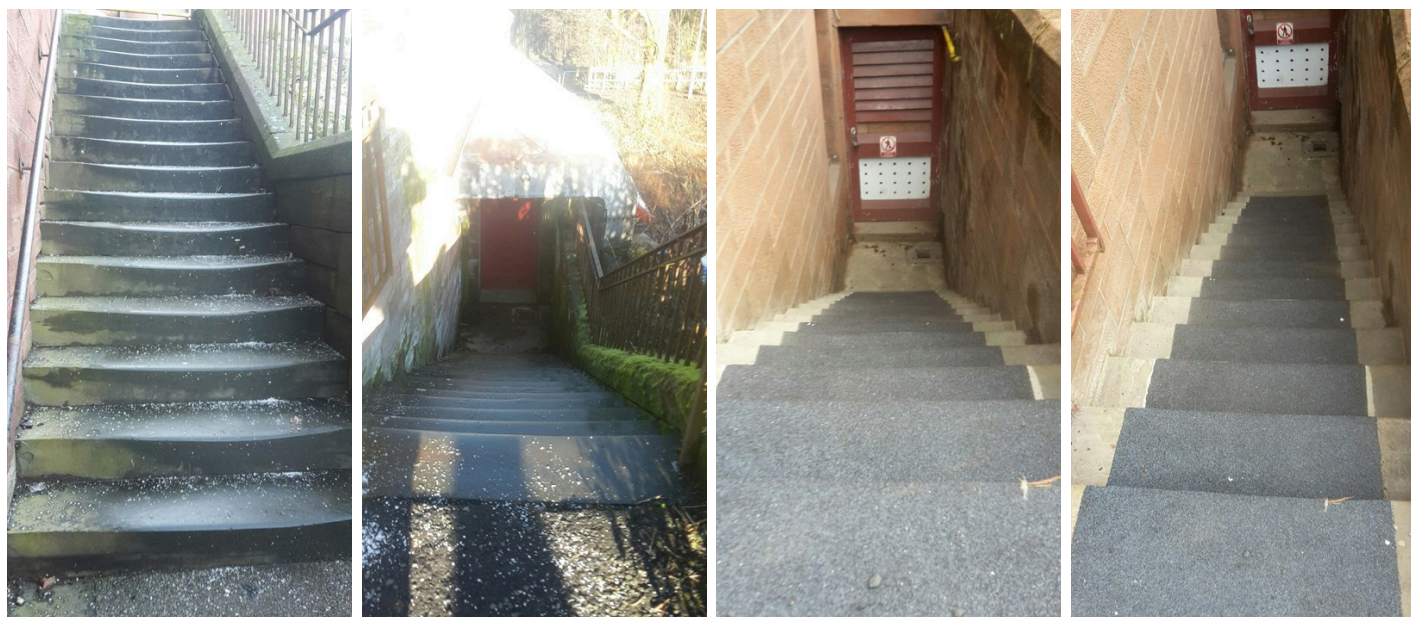
Photograph Descriptions

A potential slip hazard had been noted on several sets of sandstone steps. Due to the enclosed area it was often damp or icy in the winter. A durable long lasting solution was required to ensure the slip hazard could not reoccur in the future.

- * 1- Gritted steps in winter to try and prevent slippages ,
- * 2- Top down view showing dampness of steps ,
- * 3- Belzona system applied with 9211 aggregate ,
- * 4- Completed application ,

Several staircases around a hospital in Glasgow has significantly worn away.

The steps were marked out & prepared using a floor grinder. Belzona 5821 was then applied as a 1 coat system. Immediately following this Belzona 9211 aggregate was blinded into the coating & tamped down.

Removal of the steps would not have been an option. Non slip tapes have been found to have limited durability in this environment. The Belzona solution was completed within two weeks on seven sets of steps.
