# SPALLED CONCRETE IN A HIGH TRAFFIC AREA RECOVERED AND PROTECTED BY BELZONA

Industry: *Pulp & Paper*  
 Application: *FPA-Floor Problem Areas*  
 Substrate: *Concrete*  
 Products: *\* Belzona 5231 (SG Laminate) ,*  
*\* Belzona 5233 ,*

Customer Location: *Oregon, USA*  
 Application Date: *November 2017*

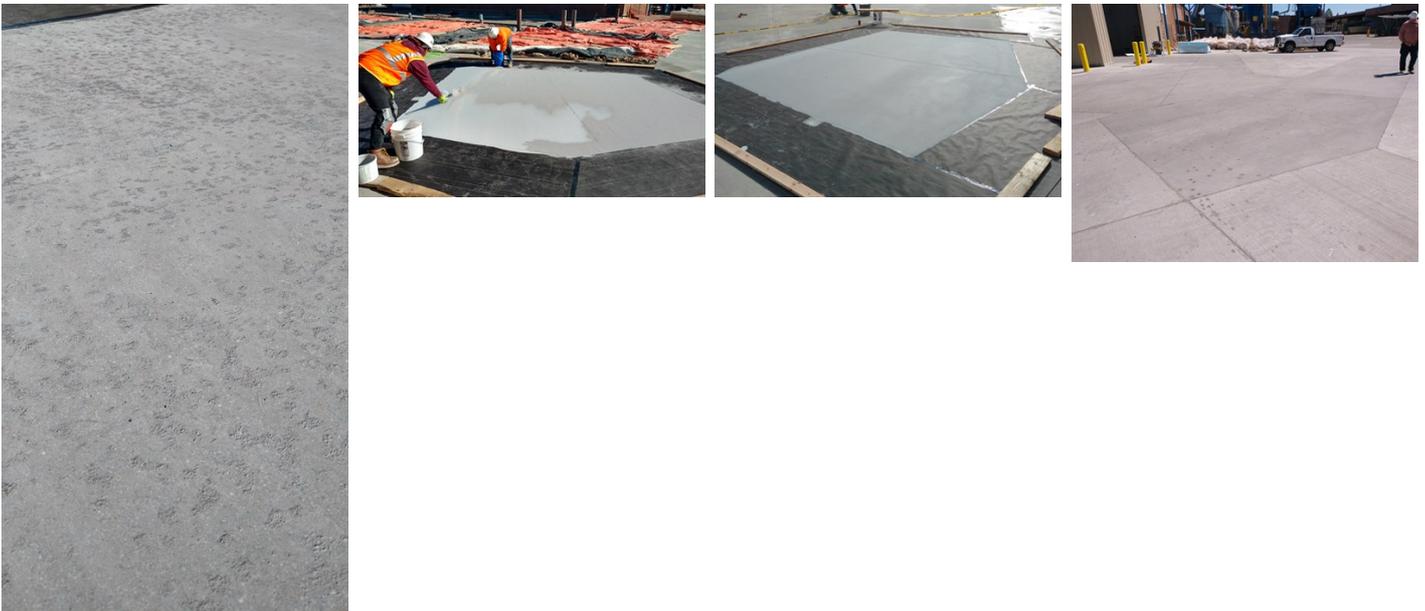
*Fresh concrete section that was poured developed severe spalling and pits. The customer was concerned that this would open up this section for water to penetrate the pad and through the winter the water would freeze and cause even worse damage. The customer required a material that would not be smooth and slippery, and they wanted it to "look like concrete".*

- \* 1. Original condition showing the spalling and pitting. ,
- \* 2. Belzona 5231 applied, the aggregate being spread. ,
- \* 3. Belzona 5231/5233 application complete. ,
- \* 4. The application after 6 months. ,

We waited for the fresh concrete to fully cure. Surface prep was done with hand grinders to remove all of the surface laitence and loose material from the spalling. There were still some areas of deeper pitting that we addressed by "flooding" on the first layer. The first layer, Belzona 5231 in light gray color, was applied using a squeegee to spread it around, and smoothed over using a roller. Then a light gray quartz aggregate spread by hand to refusal. We allowed that to cure for a couple hours, and then we were able to vacuum the excess aggregate off the top and apply the second layer, Belzona 5233 Clear with rollers and allowed to fully cure.

Due to the weight that travels across this, the concrete pads are 16" thick and replacement was the only other option, which was cost-prohibitive. This repair was only a few hundred U.S. dollars and was available for use in only a few days versus an additional 4-6 weeks for new concrete to cure. After inspection 6 months later, after a full winter season, the application looked just as it had looked when it was applied. No scratches, scrapes, chips, or damage of any kind could be found.
