SPALLED CONCRETE IN A HIGH TRAFFIC AREA RECOVERED AND PROTECTED BY BELZONA

ID: 7714

Industry: *Pulp & Paper*
 Application: *FPA-Floor Problem Areas*
 Substrate: *Concrete*
 Products: ** Belzona 5231 (SG Laminate),*
** Belzona 5233,*

Customer Location: *Oregon, USA*
 Application Date: *November 2017*

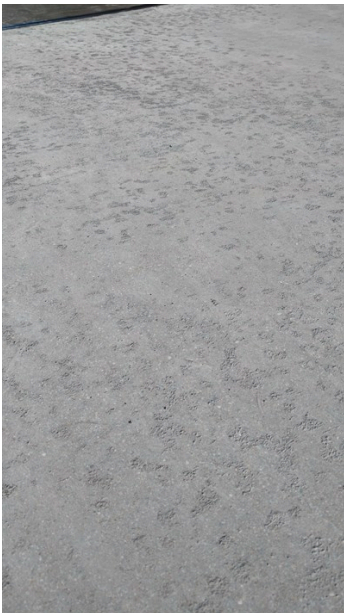
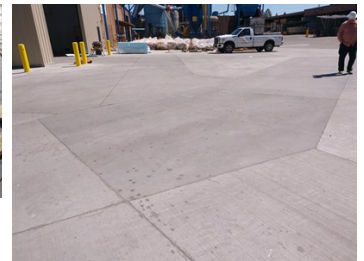
Photograph Descriptions

Fresh concrete section that was poured developed severe spalling and pits. The customer was concerned that this would open up this section for water to penetrate the pad and through the winter the water would freeze and cause even worse damage. The customer required a material that would not be smooth and slippery, and they wanted it to "look like concrete".

- * 1. Original condition showing the spalling and pitting. ,
- * 2. Belzona 5231 applied, the aggregate being spread. ,
- * 3. Belzona 5231/5233 application complete. ,
- * 4. The application after 6 months. ,

We waited for the fresh concrete to fully cure. Surface prep was done with hand grinders to remove all of the surface laitence and loose material from the spalling. There were still some areas of deeper pitting that we addressed by "flooding" on the first layer. The first layer, Belzona 5231 in light gray color, was applied using a squeegee to spread it around, and smoothed over using a roller. Then a light gray quartz aggregate spread by hand to refusal. We allowed that to cure for a couple hours, and then we were able to vacuum the excess aggregate off the top and apply the second layer, Belzona 5233 Clear with rollers and allowed to fully cure.

Due to the weight that travels across this, the concrete pads are 16" thick and replacement was the only other option, which was cost-prohibitive. This repair was only a few hundred U.S. dollars and was available for use in only a few days versus an additional 4-6 weeks for new concrete to cure. After inspection 6 months later, after a full winter season, the application looked just as it had looked when it was applied. No scratches, scrapes, chips, or damage of any kind could be found.
