Belzona Repairs Voith Schneider Unit

ID: 7722

Industry: Marine
Application: SOS-Ships and Offshore Structures

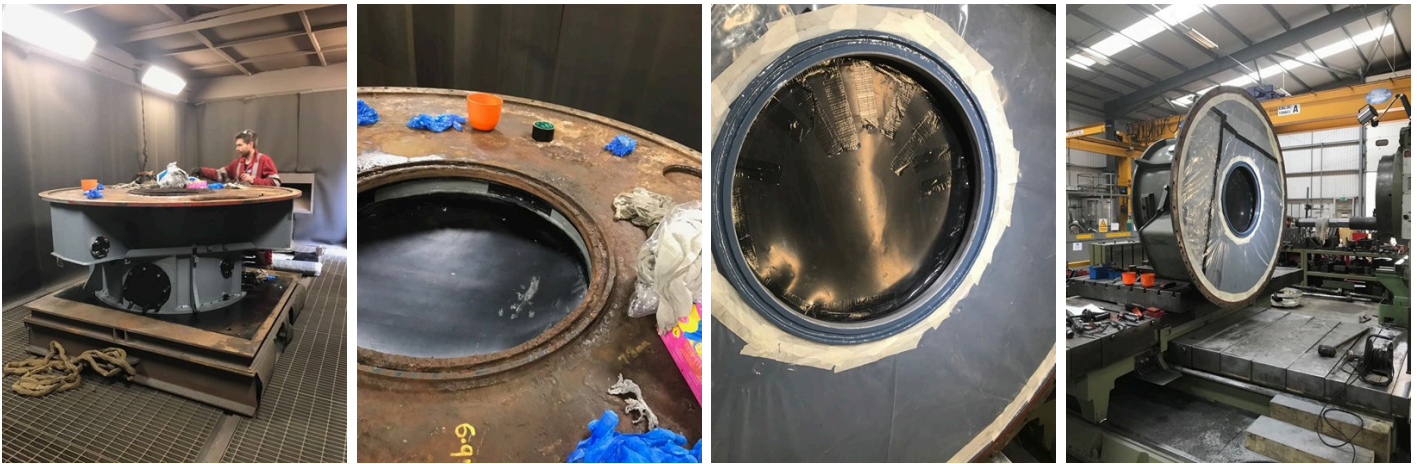
Photograph Descriptions

Erosion/corrosion damage meant the unit no longer functioned correctly. Replacement of the unit would total around £120,000

- * 1. Voith unit in blast booth ,
- * 2. Close up of metal loss ,
- * 3. Sealing face built up ,
- * 4. Machining of product ,

A Voith Schneider propulsion unit was experiencing erosion/corrosion from sand/silt & sea water in service.

The face of the unit was first grit blasted to SA2.5 & 75 microns. The face of the casing was then built up with Belzona 1311 before being overcoated with Belzona 1321. The inner bore was a sealing face, it was built up with Belzona 1311 & then machined down to a close tolerance.
