Belzona Chocking Compound Stabilizes Lathe

ID: 7725

Industry: *Pulp & Paper*
Application: *GSS-Gaskets, Seals and Shims*
Substrate: *Concrete*
Products: ** Belzona 7111 (Industrial grade) ,*

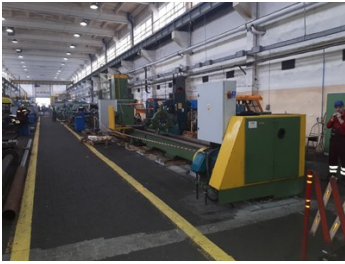
- * The new lathe to be chocked. ,
- * The application is underway. ,
- * The completed solution. ,

Newly installed lathe at a paper manufacturer required a solid foundation.

The application was carried out in accordance with a modified version of Belzona Know-How System Leaflet GSS-13.
