# CIP bund coating

**Industry:** Chemical & Petrochemical  
**Application:** TCC-Tanks and Chemical Containment Areas  
**Substrate:** Concrete  
**Products:** \* Belzona 4131 (Magma-Screed) ,  
\* Belzona 5811 (Immersion Grade) ,

**Customer Location:** Scotland  
**Application Date:** April 2018

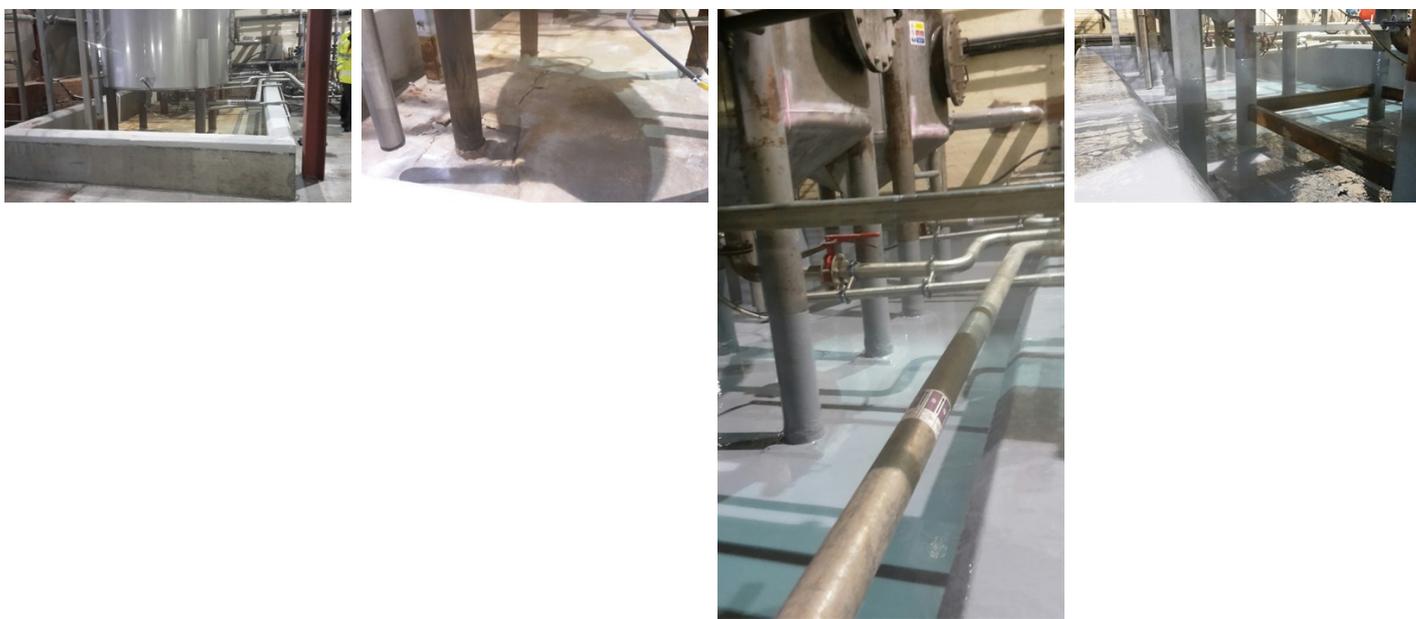
\* 1 - overview of the bund 2 - failed GRP lining showing cracks 3 - Two coats system of Belzona 5811 applied to the concrete & onto the tank legs 4 - completed application ,

A CIP chemical bund had a GRP lining in place. This lining had started to break down & de-laminate on large areas of the bund.

Application was carried out in accordance with Belzona system leaflet TCC-15. The failed lining was removed & the concrete was prepared with floor grinders. The walls were then filleted with Belzona 4131 Magma screed. Two coats of Belzona 5811 Immersion Grade were then applied to provide corrosion protection.
