# Brewery vessel coating

ID: 7727

Industry: Food & Drink  
Application: TCC-Tanks and Chemical Containment Areas  
Substrate: Steel  
Products: \* Belzona 5892 ,

Customer Location: Scotland  
Application Date: April 2018

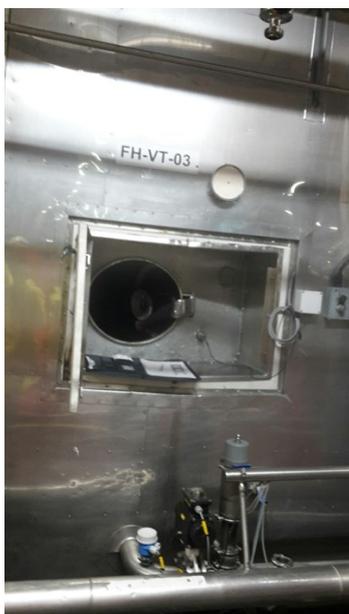
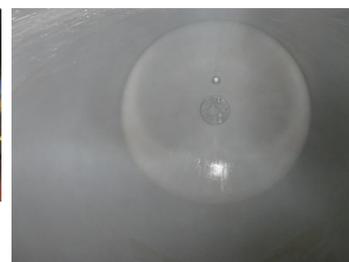
The original lining had started to break down. A corrosion resistant system that would not taint the final product was required. Dust was not permitted to escape the working area due to production going on in the surrounding area.

- \* 1 - Vessel manway ,
- \* 2 - Breakdown in original lining ,
- \* 3 - Habitat to contain any sponge media from the blasting process ,
- \* 4 - Belzona 5892 applied ,

The application was carried out in accordance with Belzona System Leaflet TCC-03. A sponge blast system was used to remove the

failed lining & to prepare the underlying metal. Two coats of Belzona 5892 were then applied. The coating was post cured at 30 degrees C to comply with the WRAS potable water requirements.
