Brewery vessel coating

ID: 7727

Industry: Food & Drink
Application: TCC-Tanks and Chemical Containment Areas
Substrate: Steel
Products: * Belzona 5892 ,

Customer Location: Scotland
Application Date: April 2018

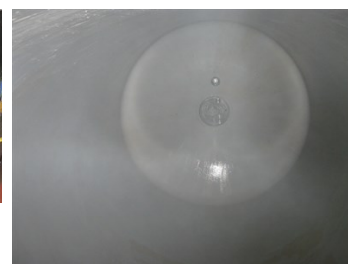
Photograph Descriptions

The original lining had started to break down. A corrosion resistant system that would not taint the final product was required. Dust was not permitted to escape the working area due to production going on in the surrounding area.

- * 1 - Vessel manway ,
- * 2 - Breakdown in original lining ,
- * 3 - Habitat to contain any sponge media from the blasting process ,
- * 4 - Belzona 5892 applied ,

The application was carried out in accordance with Belzona System Leaflet TCC-03. A sponge blast system was used to remove the

failed lining & to prepare the underlying metal. Two coats of Belzona 5892 were then applied. The coating was post cured at 30 degrees C to comply with the WRAS potable water requirements.
